## Integrated Geo-Hazard Risk Assessment of Critical Barsa Watershed under Chukha Dzonkhag

Department of Geology and Mines

Field Season: 2016-2017

This report is in accordance with the work plan of the Department of Geology and Mines, MoEA under the National Adaptation Programme of Action II (NAPA II) Project titled '*Addressing the Risks of Climate-Induced Disasters through Enhanced National and Local Capacity for Effective Actions*', funded by GEF-LDCF through UNDP and implemented by RGOB.

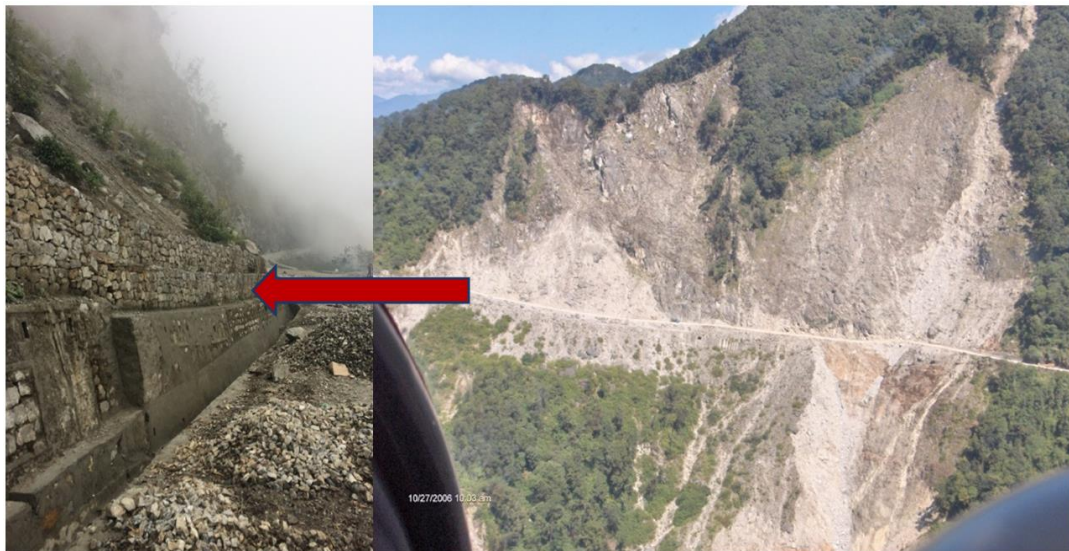
The slope angle of slide ranges from  $50^{\circ}$  to  $80^{\circ}$  and the loosely composed materials are seen hanging on the slope face which is protected by retaining wall at the base (Figure 12). A bulging of retaining wall was observed, which indicates that the area is not stable and there is constant movement of mass over the period.

Figure 12. Jumja slide with bulging retaining wall as shown in the picture. Inventory ID: *Isd02100141*.

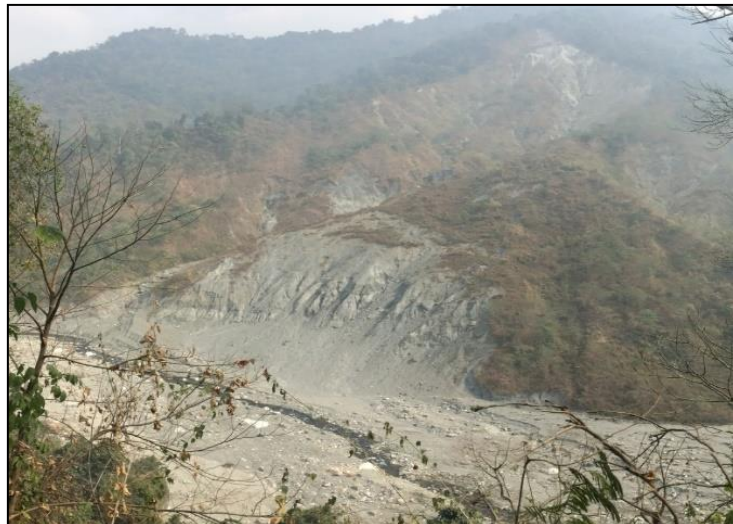
Two grab soil samples namely, LS-2(a) and LS-2(b) were collected from the middle and base of the slide respectively, to test their particle size distribution in the Geo-tech laboratory. From the grain size graph in Figs. 19 and 20, the soil distribution curves are slightly smooth and concave which could mean that it is a well-graded soil. Moreover, the coefficient of curvatures of these two soil samples of 0.245 and 0.99 are greater than 0.1 means they are well-graded soils. The well-graded soils have higher resistance to erosion than a poorly-graded soil. As seen in Figure 13, the slide is slightly stable due to the presence of vegetation growth as compared to Jumja slide, which has gap graded soil with less vegetation.

*Figure 13. Landslide located about 500m North of BFAL industry, at the left bank of Barsa River. (Inventory ID: lsd02150055).*

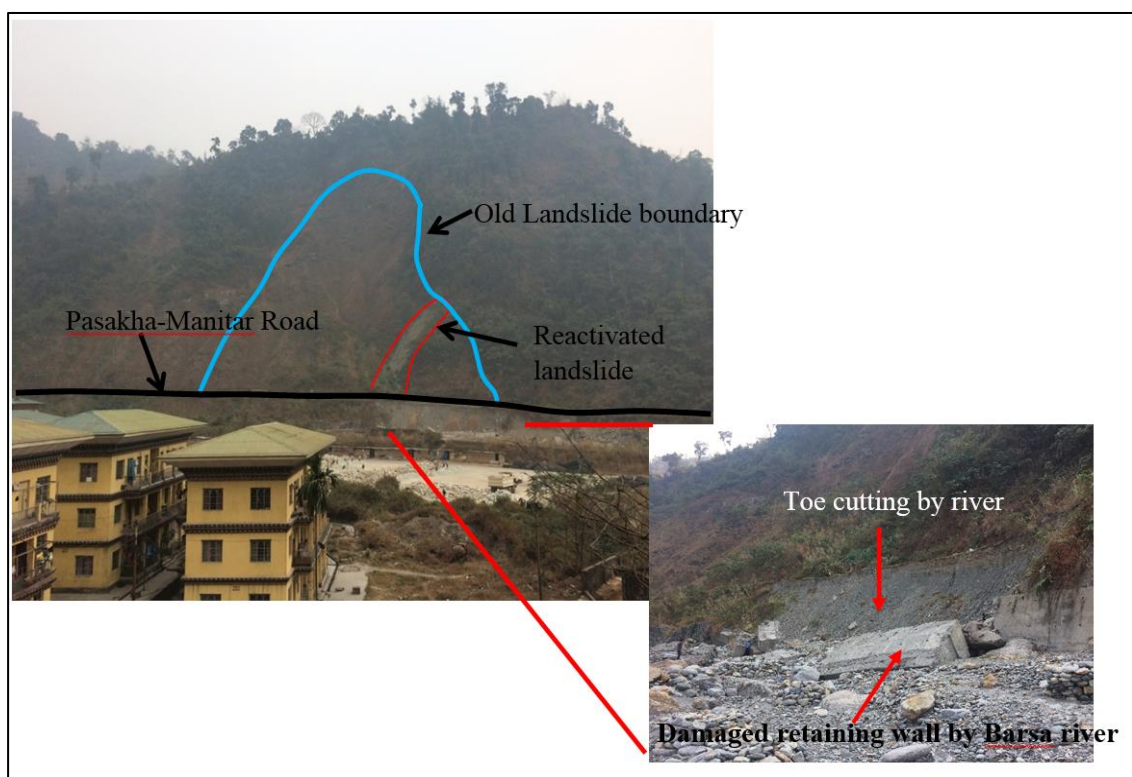
From the local source, this slide has occurred in the year 2000, after the course of a flash flood in Pasakha. The slide area is composed mostly of phyllite with about 40 m thick calcareous quartzite on the top section of the slide. The crown of the slide is made up of quartzite and has a steep slope angle of about  $80^\circ$  whereby, some signs of minor tension cracks are visible. The landslide is dormant for almost 14 years since its last major slide in 2000. Except for a small reactivation of slide at the south-east part of the slide slope as seen from Figure 14, the remaining part of the slide surface have a thick growth of bushes.

Figure 14. Landslide (Inventory ID: lsd02150230) seen from the BFAL colony.

Just below this landslide or the road as seen from Figure 14, there is an active toe cutting erosion by Barsa river. Some part of the retaining wall that was constructed to resist the slope failure is also damaged, which has led to further mass wastage below the road. There is an ongoing flood protection wall being constructed on the right bank of Barsa river/river beside BFAL housing colony, which is financially supported by NAPA-II project. Although this wall will benefit and protect the BFAL

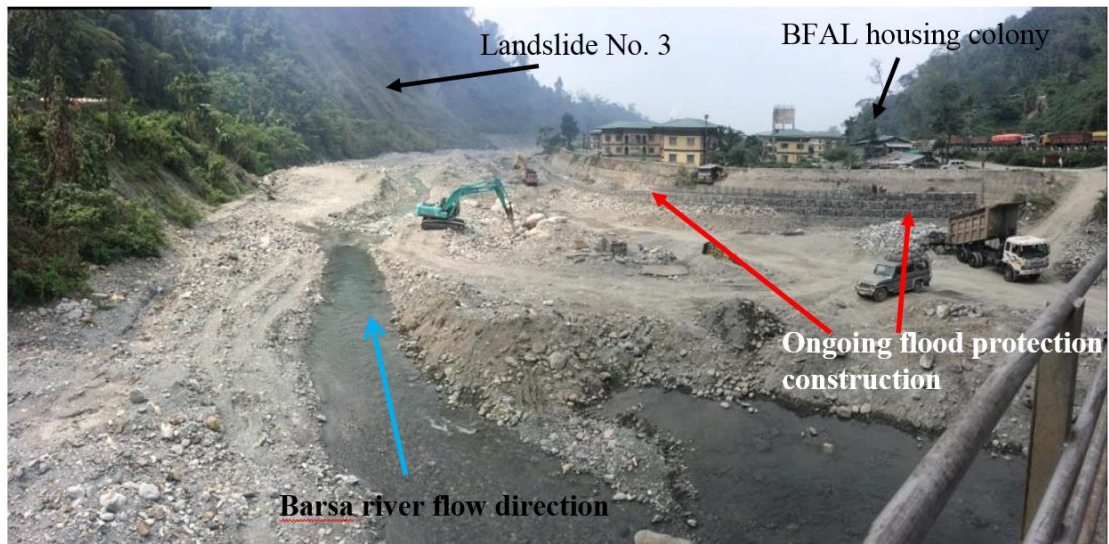
colony from the future flood, care must be taken on the left bank of Barsa river where the Pasakha-Manitar road passes through (Figures 14 and 15). The present flood protection wall construction might alter the course direction of Barsa river towards the left bank and this will increase water current force along the slopes below the road. This force could further increase toe cutting erosion and destabilize the slope which will reduce the stability of the road.

Figure 15. Disturbance in Barsa river course due to ongoing river protection wall.

Therefore, construction of river protection wall along the slopes on the left bank of Barsa river is important to avoid undercutting erosion from the river which otherwise could damage the road passing above.

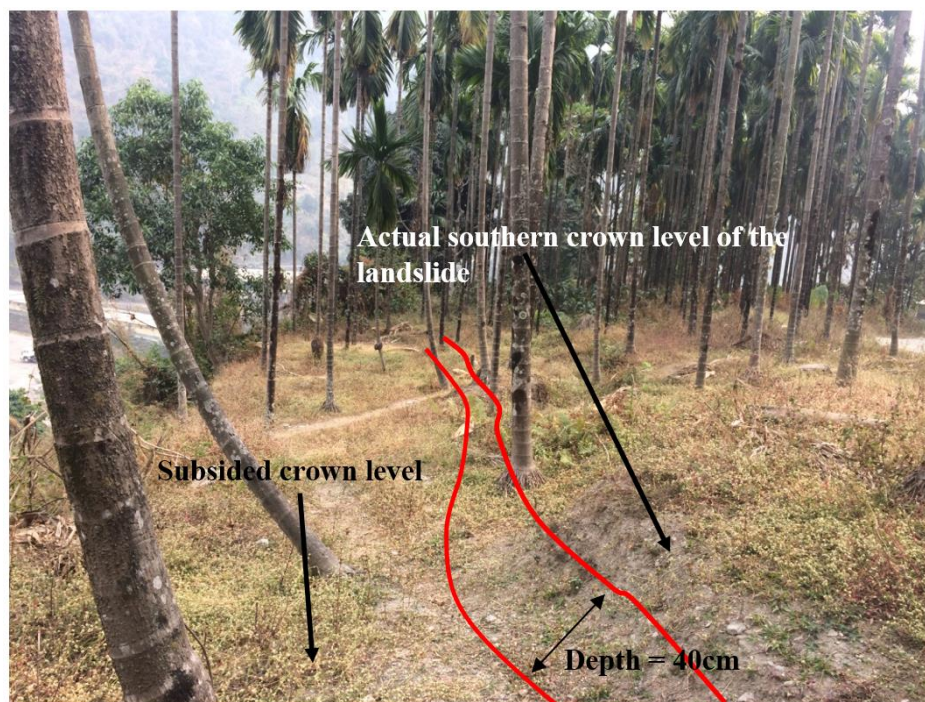
of highly weathered phyllite. Full grown trees show signs of bending at the bottom part of the trunk and straight growth at the upper part of the trunk. This indicates there was creep movement in past years and has remained dormant in later years as shown in Figure 16. The presence of residual soils in this area also indicates that there was not much mass wastage taken place. However, in the southern crown part of the landslide, a mass subsidence length of about 4m and a depth ranging from 10 to 40 cm was observed. Therefore, there are chances of landslide reactivation from heavy rainfall and toe cutting erosion as it lies close to the right bank of Barsa river. It may not be advisable to construct any structure nearby the crown of the slide or within the dormant slide as there are indications of subsidence and creep movement as seen in Figure 16.

Figure 16. Subsidence at the crest of the slide and slanting trees due to movement of the ground.

The landslide-Isd02150253 seems to indicate there was creep movement in past years and has remained dormant in later years (Figure 16). Therefore, there are chances of landslide reactivation from heavy rainfall and toe cutting erosion as it lies close to the right bank of Barsa river. It is not advisable to construct any structure

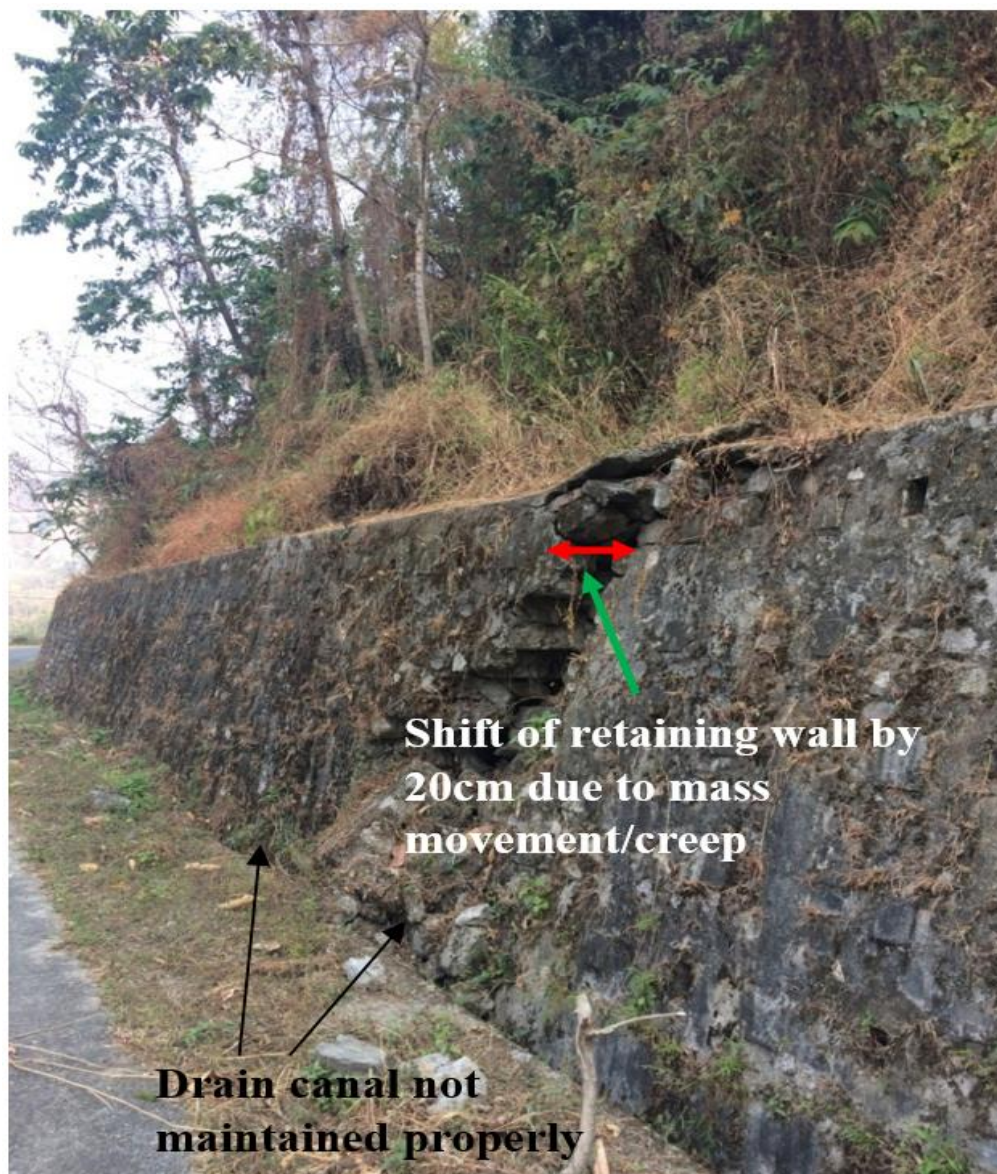
and overflowing on the road surface that will further deteriorate road and slope conditions.

Figure 17. Displacement of retaining wall due to a mass movement.

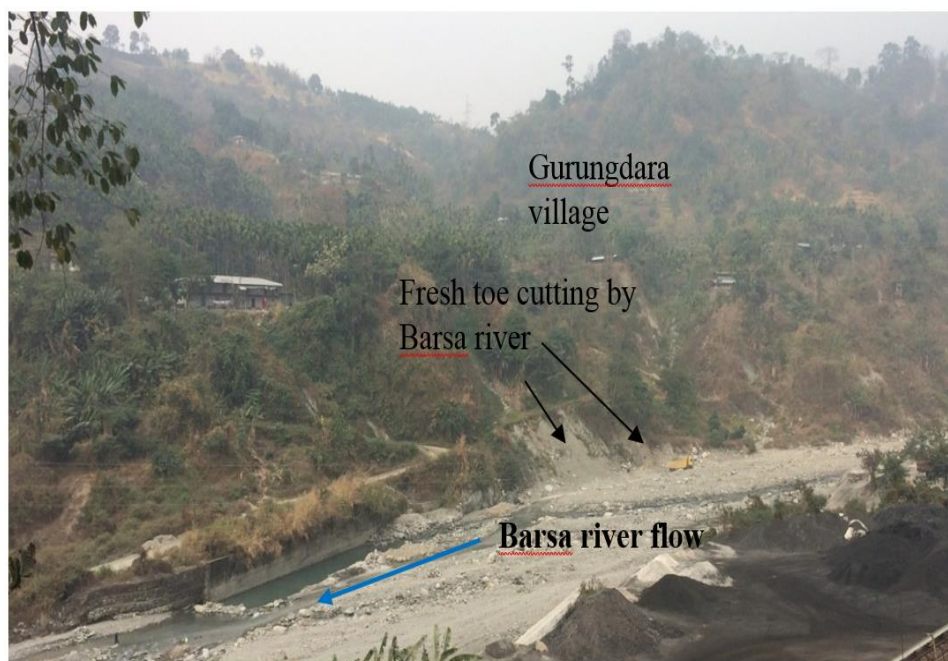
About 200 m NE of Pasakha Power Substation, below the house of Buddhi Man Rai, on the right bank of Barsa river, a fresh toe cut by river Barsa is observed (Figure 29). River protection wall along the base of this toe cut area is necessary to prevent further aggravation of toe cutting and to counter re-activation of dormant landslide above. And, a BPS tower located on the top of the landslide crown. Just below the toe cut area, there exists a stretch of river protection wall, of which some sections are badly damaged, and these disturbed parts need to be replaced by new protection walls.

Figure 29. Showing the fresh toe cutting by Barsa river.

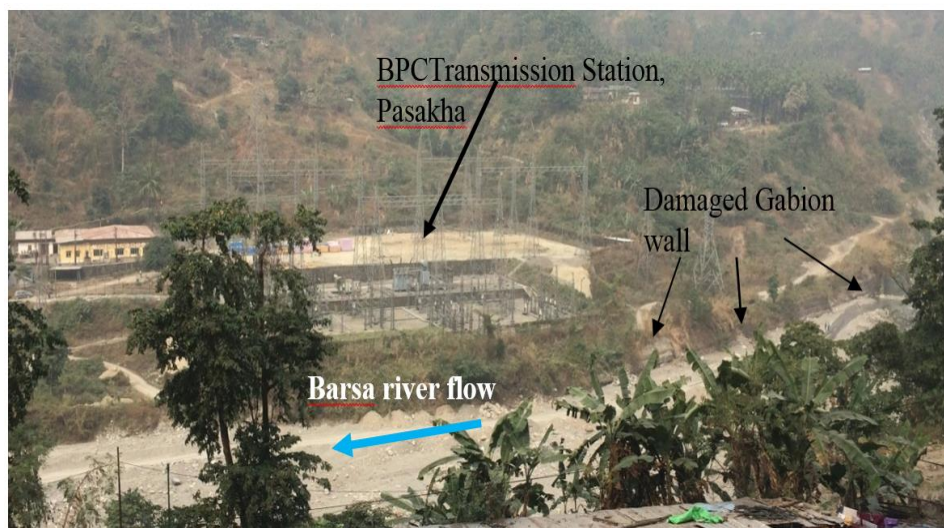
The BPC transmission station in Pasakha is located quite close to the right bank of Barsa river. There exists a long stretch of old and badly damaged gabion wall built along the base of the power substation to countermeasure flooding from Barsa river (Figure 30). This existing damaged wall might not be effective enough to protect the substation from the flood. Therefore, a better river training wall is required over the existing wall to protect the station from flood and stabilize the slope as well.

*Figure 30. Pasakha transmission station with disturbed gabion wall along the right bank of the river.*

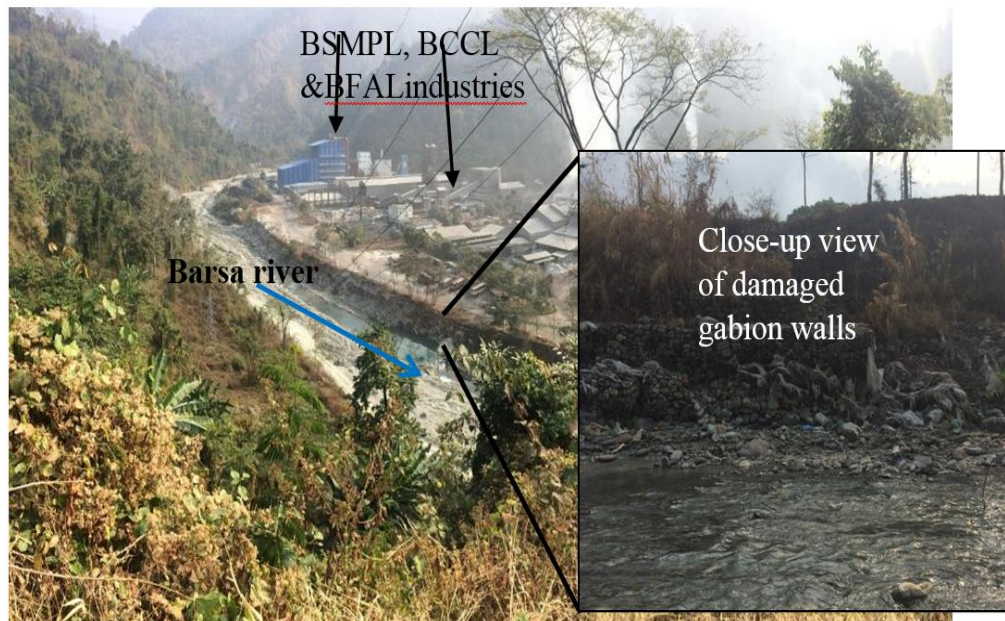
Along the left bank of river Barsa, there exist a long gabion wall, which was built to protect the industrial area from Barsa river flood (Figure 31). These old lengthy walls are now badly damaged through the passage of time as seen in the inset photo below and might not be too effective flood protection in the future. Therefore, new and better flood protection structures along the existing damaged walls are necessary to prevent toe erosion from Barsa river.

Figure 31. Photo shows damaged gabion walls along the left bank of Barsa river below the industries.
