Integrated Geo-Hazard Risk Assessment of Critical Landslide at Box-Cutting, Gelephu-Zhemgang Highway, under Sarpang Dzongkhag

Department of Geology and Mines

Field Season: 2015-2016

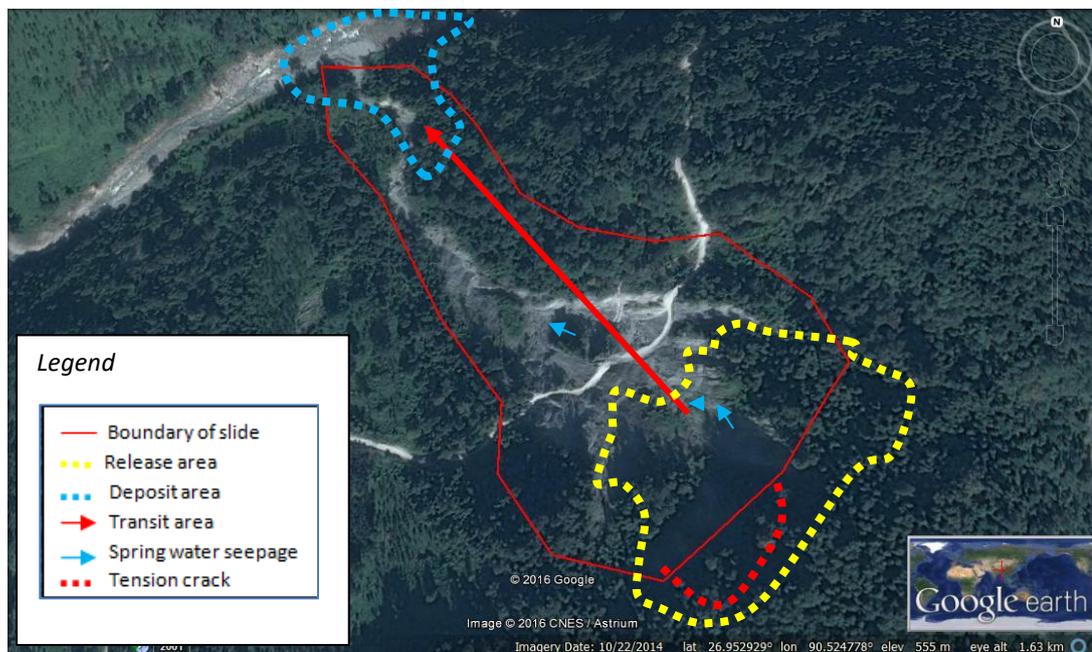
During the site investigation in the rockslide area, the detailed mapping of tension cracks and the boundary of the sliding mass were carried out and shown on the Google map (Figure 5). The approximate boundary of the whole unstable and moving mass was also mapped. The largest opening is around 2 to 3 m wide and the smallest is around 1-2mm. The unstable and stable grounds are easily differentiated at the site as the cracks mark the boundary between these two areas (Figure 5).

Figure 5. Engineering geological mapping of release area, transit area, deposit area, water seepages, tension cracks and boundaries of the slide (Google Earth).

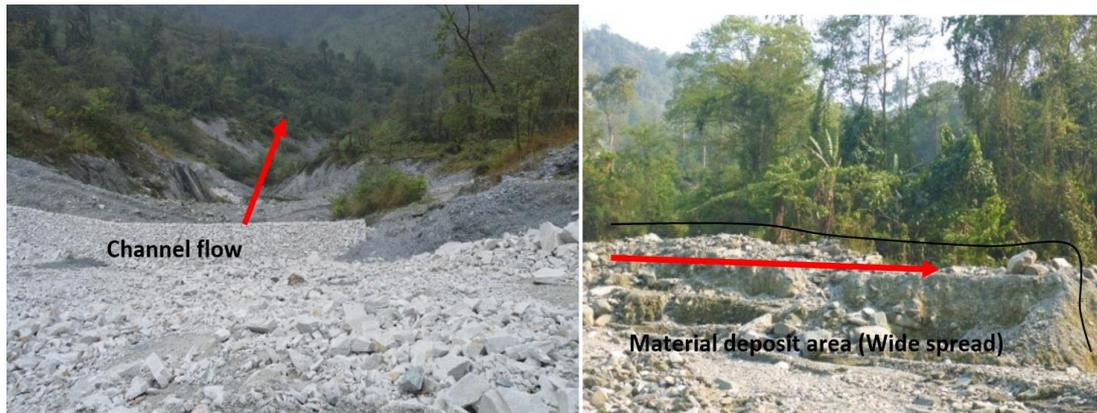
In general, the sliding rock mass has been channelled as the material reached towards the toe of the area, but as the mass reaches to the toe the material has widely spread forming fan-like structure (Figure 6). The boulders are seen at the deposit area. The bedrocks are visible along the material flow. It is not easy to identify the types of the sliding when investigating from the toe of the rockslide. The toe of the rockslide joins with Galechu, where, the materials deposited are mostly eroded away.

Figure 6. Field photos showing the channel flow and deposit area.

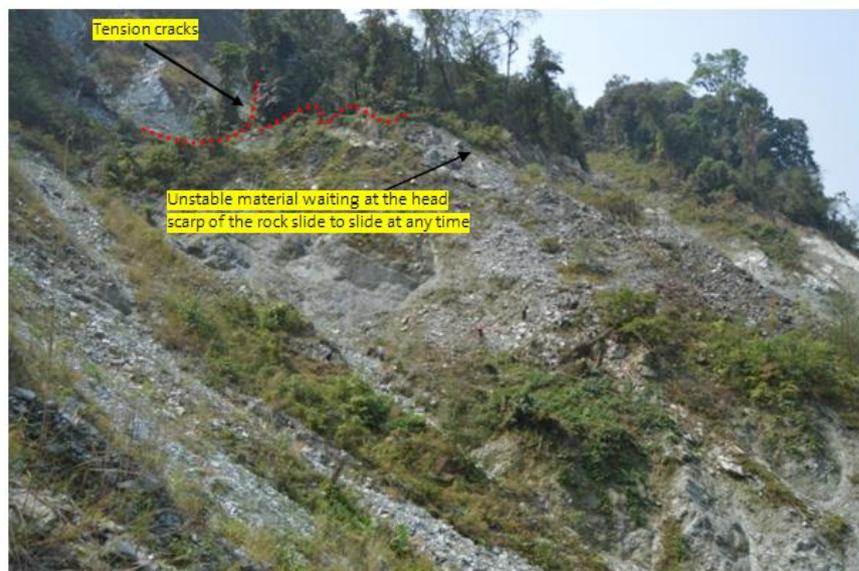
At the head scarp of the rockslide, tension cracks with few mm to few cm openings are aligned in ENE to WSW orientation and unstable materials were observed (Figure 7). The tension cracks are mostly deep indicating greater depth location of sliding or rupture plane and thus estimating the depth to rupture plane and classification of slide type is a challenge in the area. This rockslide may, therefore, be classified as moderately deep-seated slide because of the rupture surface located a few meters below the surface.

Figure 7. Head scarp of the slide showing unstable materials and cracks.

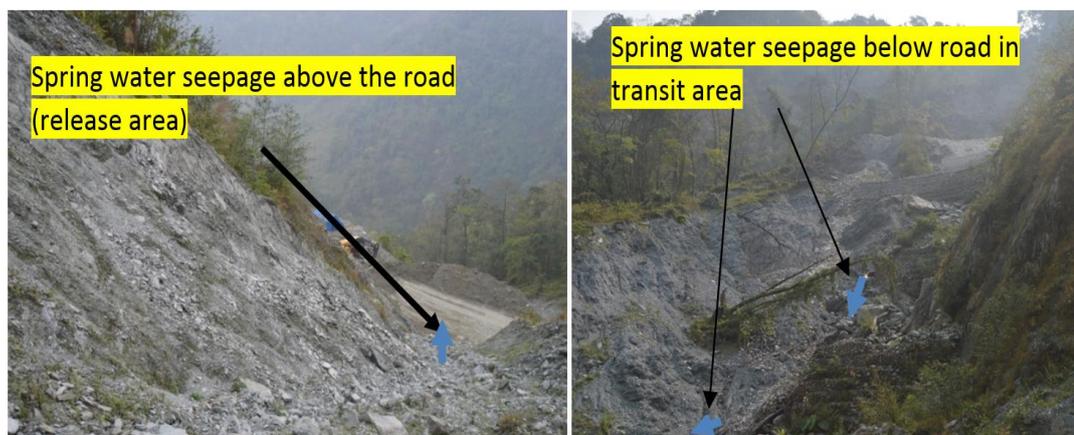
A small spring above the highway at the release area of the slide, at the head scarp and transit area of rockslide body, were observed (Figures 5 and 8). Generally, spring water flows out of the formation through contact of rupture surface, and therefore the outlets of several springs were mapped within the sliding area. The information on groundwater observation in the study is not available. In general, the study area receives a high amount of the rainfall for long period during monsoon and therefore it is expected that the groundwater table will increase drastically during monsoon season favouring the instability of the slope. The water seepages in the slide area are managed poorly facilitating the slope failure in the area (Figure 8). Thus, it is most likely that one of the main factors facilitating landsliding in Box-Cutting is high water saturation.

Figure 8. Small spring waters were observed within the release and transit area.

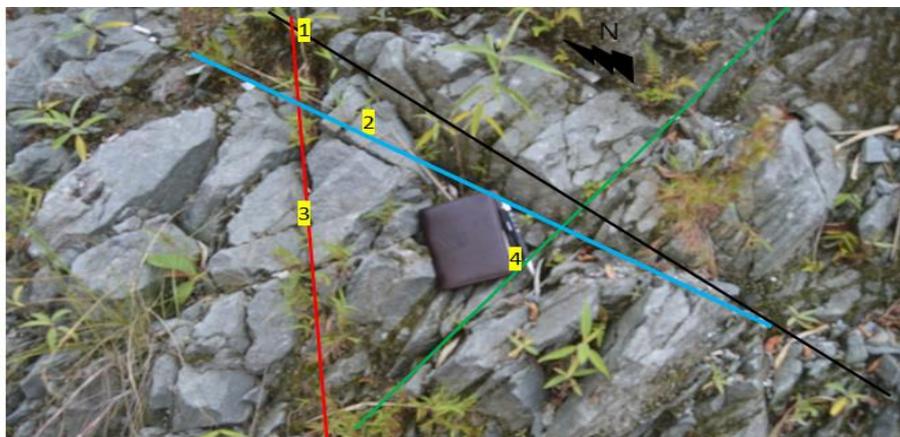
The four prominent joint sets were observed on the quartzite outcrop located above the unstable area (Figure 9). The attitude of the bedding plane of quartzite is 49/265.

Figure 9. Outcrop of relatively competent quartzite bedrock showing four sets of joints.

The joint sets within quartzite have persistency of 2-3 m and high ranges of the spacing (10 mm to 1 m). The openings are filled with silt and small bushes at places. The quartzite bedrock, in general, is highly fractured and moderately weathered.

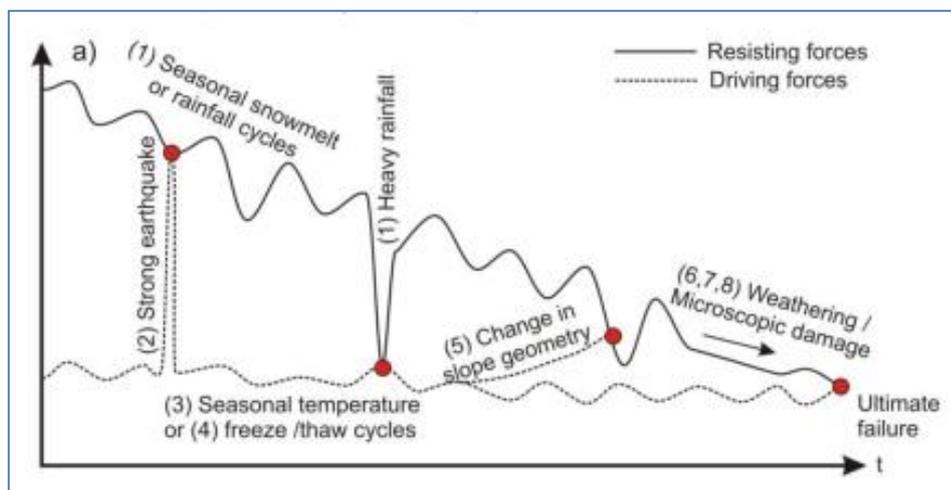
Figure 13. A conceptual model of driving and resisting forces in the slide area.

During rainfall, water percolates through the tension cracks of the rock mass at the main scarp of the rock slide. This will increase the groundwater table within the area and increase pore pressure against the fractured weak rock mass. Further, gravity will play a huge role as the nature of the slope is very steep. All these conditions in the area will highly reduce the resistance of the rock against wedge slide and toppling. It prepares well for the rockslide as it increases the ground pore pressure and weakens the rock mass, tension cracks and allows the blocks of the rock to slide under the influence of gravity. Thus, these conditions in Box-Cutting suggests that the hydro-mechanical forces are one of the main preparatory factors for the rockslide in the area.

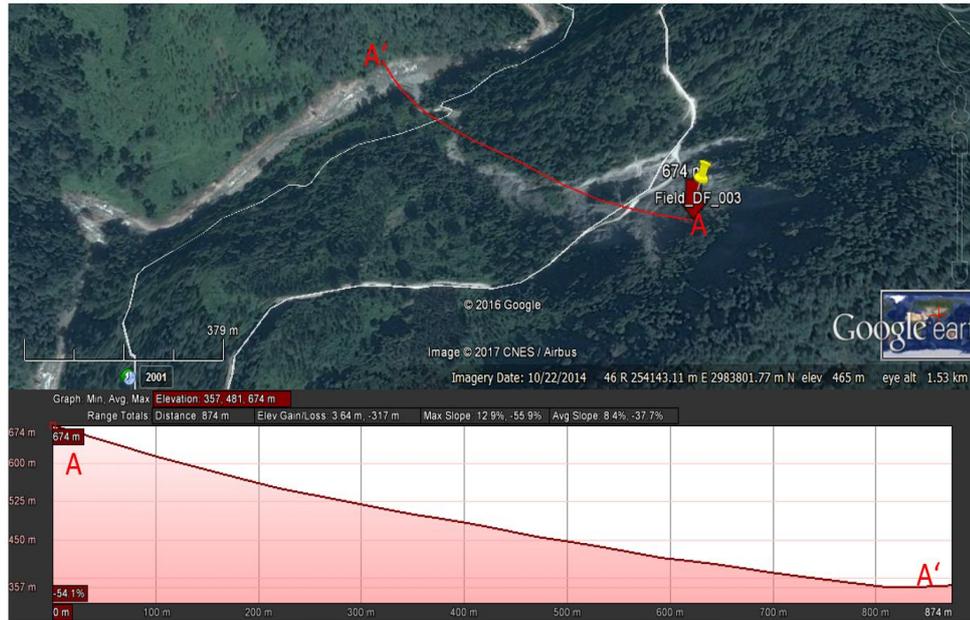
In Box-Cutting, longitudinal cross-section constructed on google earth and width of the path were used to estimate the volume of the unstable materials (Figure 14). The large volume of unstable materials was even observed during the field observation at the site. The unstable volume of the material is estimated to be around 300,000 to 400,000 m³ (L=1000 m, B=100 m and an average depth of 3 to 4 m) and used in the analysis.

Figure 14. The longitudinal cross section along A-A' constructed on google earth.

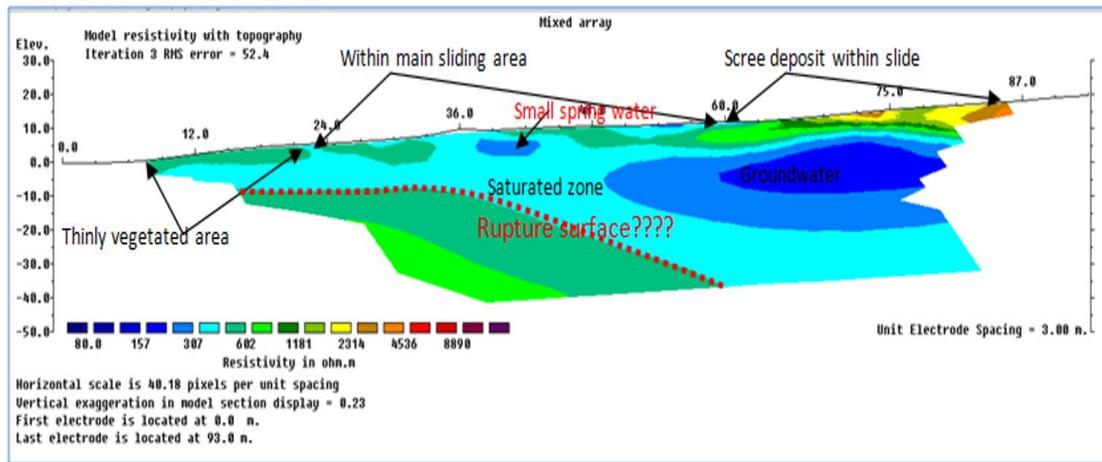
Figure 17. ZZ array configuration ERT model along profile 1.

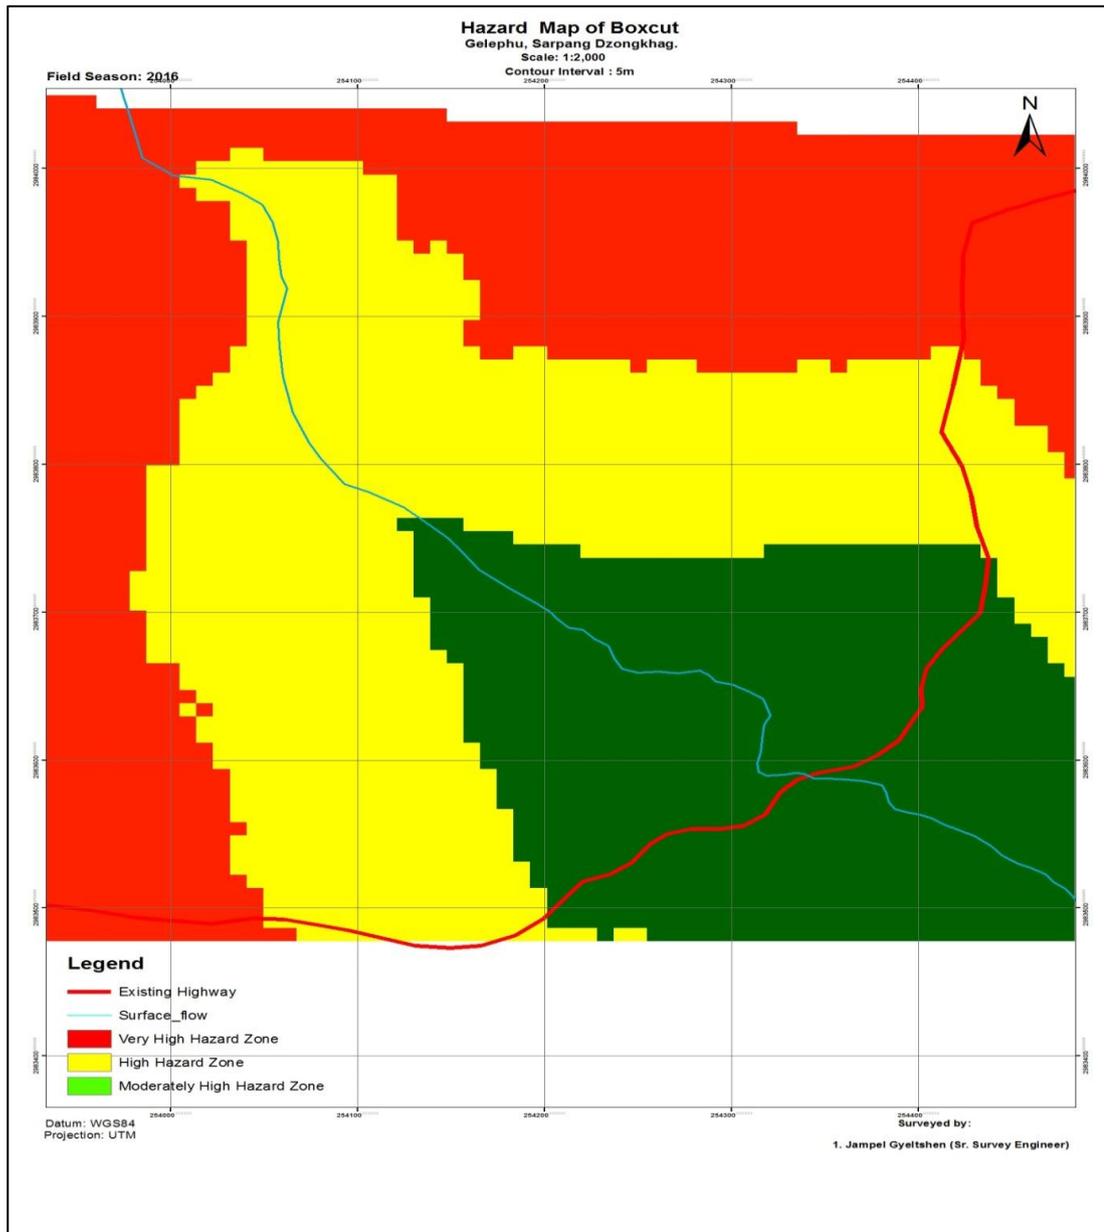
Figure 18. Hazard Zonation map of Box-Cutting slide generated using MCA in GIS.

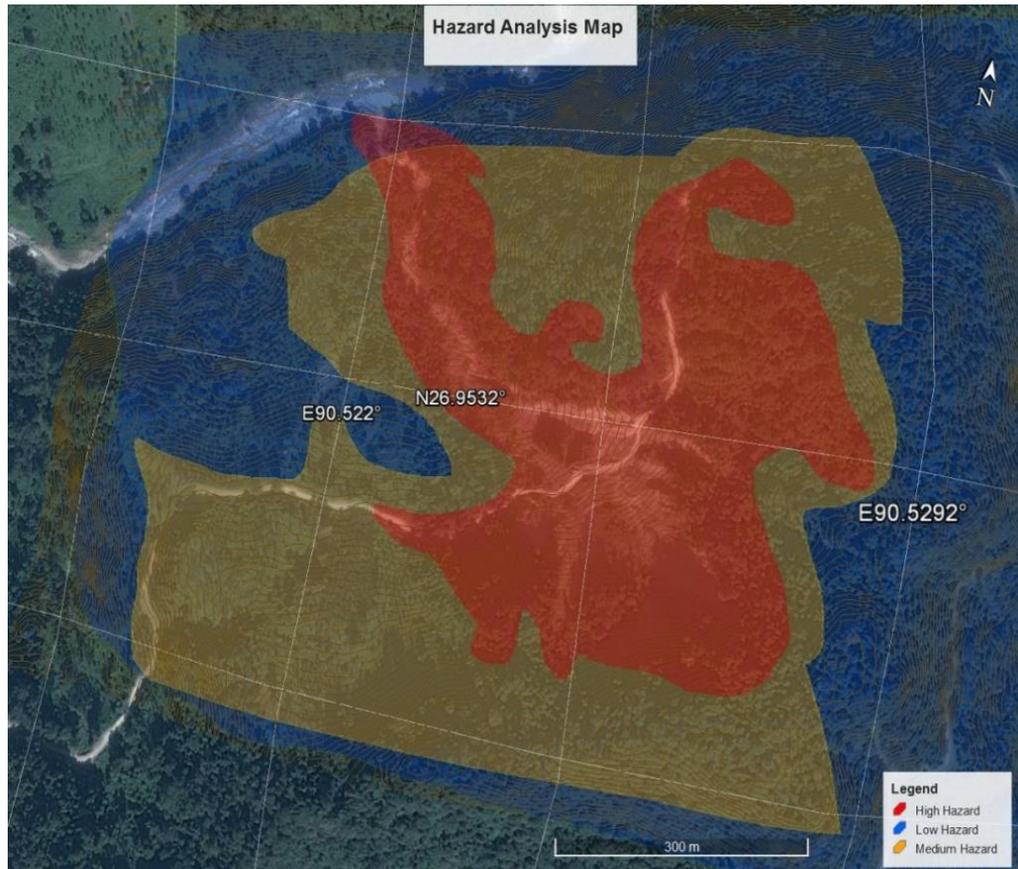
Three hazard zones are delineated (Figure 19). The area shaded with red colour is analyzed as high hazard zone. This is also the main sliding area where are is mostly barren with little or no vegetation. The zone is comprised of very weak and highly fractured rock. The shear zone occurring in the area contributes to identifying the zone as high hazard zone. The high hazard zone is the zone where the landslide and rockslide are still active. The medium hazard zone represents relatively low hazard as compared to high hazard zone. The vegetation cover is better, the slope angle has reduced, the bedrock has gained strength and the zone is exposed to a lesser hazard. This zone is shown in yellow colour and identified and mapped as medium hazard zone. The low hazard zone is marked with blue colour on the map. This zone is exposed to much lesser slide hazard than other two zones. This zone consists of very thick vegetation and much competent bedrock. This zone is less disturbed by the human activity and remained stable. These are major factors contributing to identifying the zone as a relatively low hazard.

Figure 19. Hazard zonation map of Box-Cutting rockslide generated using the the conventional method.

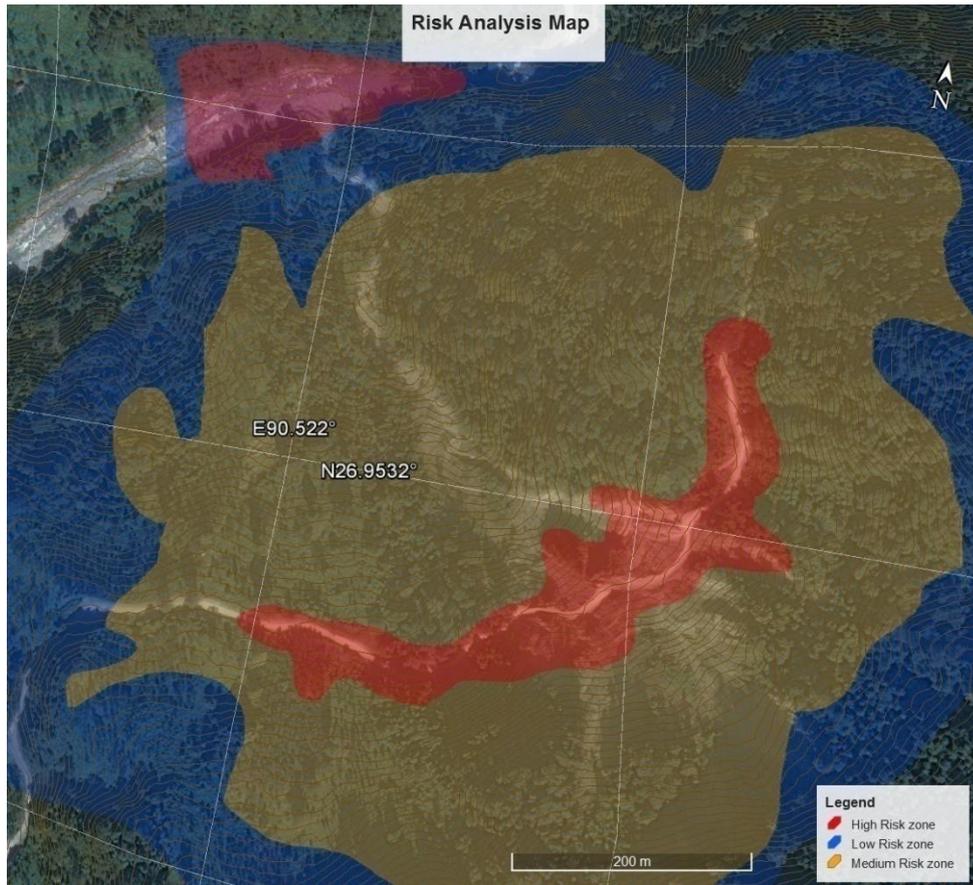
The risk is the product of vulnerability and hazard. The risk map is shown in Figure 20. The two major risks are identified in the area. The Gelephu-Zhemgang high way is directly exposed to the risk of the slide as the highway passes through the Box-Cutting rockslide. Considering the importance of this highway, the identified risk needs to be reduced with the implementation of mitigation measures. Another risk identified is artificial damming of Galechu in the downslope area by the materials of the slide, which in turn can cause an outburst of huge flood and thereby posing risk to lives and properties in the downstream areas. Therefore, failure time estimation is deemed important to mitigate the risk of damming of the stream flowing across the toe of the slide.

Figure 20. Risk map of the Box-Cutting Rockslide.

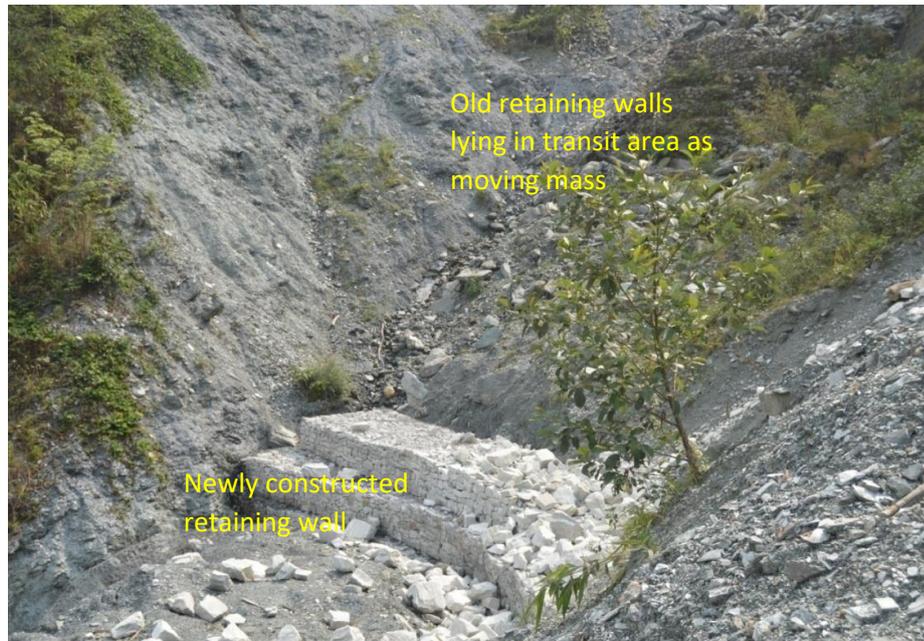
- (13) The effectiveness of the existing structural mitigation or countermeasures in the landslide to reduce risks is found to be low as their foundation is within the moving mass and therefore simply adding load to the moving mass (Figure 23).

Figure 23. Mitigation or countermeasures that are in place.

These countermeasures should be enhanced and day to day monitoring systems are required.

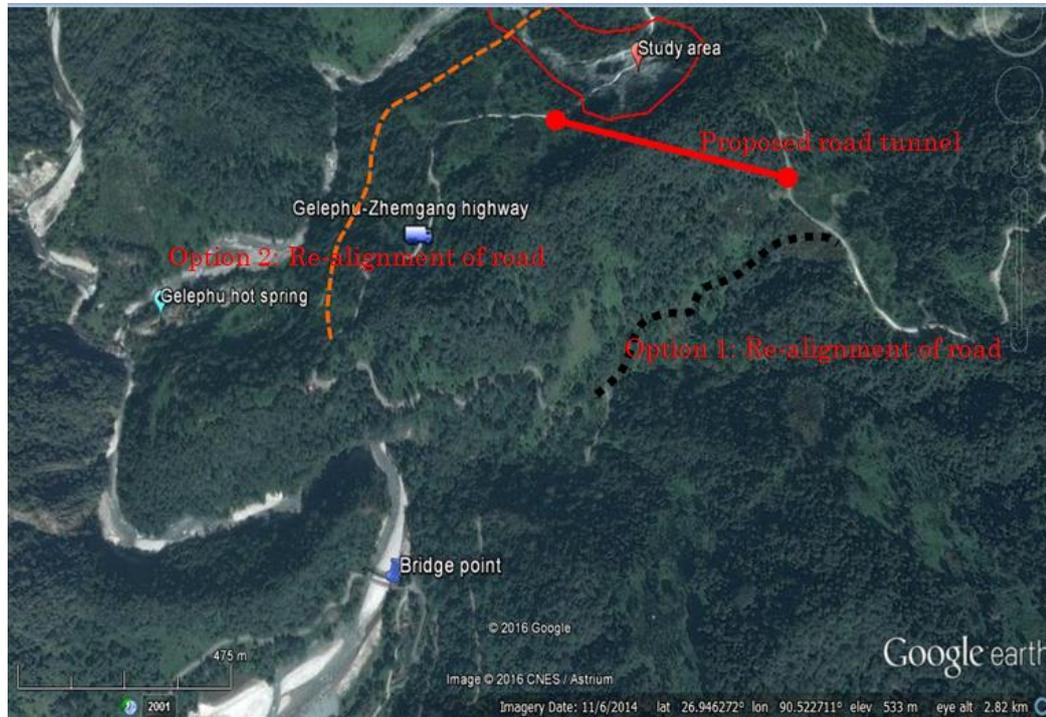
Figure 24. Proposed possible re-alignment of highway and highway tunnel.

- (1) The other alternative mitigation measures are to bypass the slide. This can be done in three different ways as shown in the Figure 24. One possible way is to either realigning the highway from other side of the ridge or through Hot spring - Rongri rough highway to avoid the slide.
- (2) Another possible bypass could be constructing a highway tunnel as shown in the Figure 24. These alternative mitigations are proposed as the slide is observed to be a recurring slide. The probable alignments are also shown in the Figure 24.
- (3) Further to reduce the risk to human lives and properties, an early warning system is also proposed to be put in place in the area. It could be placed at the site to warn the people and motorists from the danger of the rockslide.

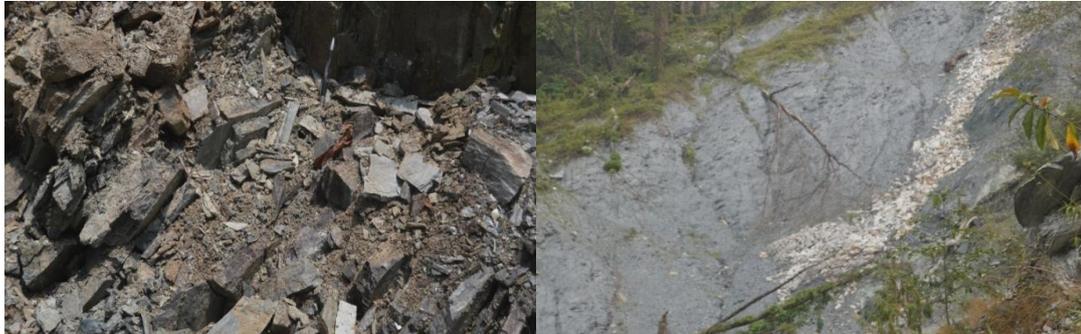
Field Photo 1 - Left photo shows the outcrop of the Quartzite and right one represents the phyllite
