# **INTEGRATED WATERSHED MANAGEMENT PLAN FOR BARSA WATERSHED**

**(Chukha Dzongkhag)**

**JUNE 2018**

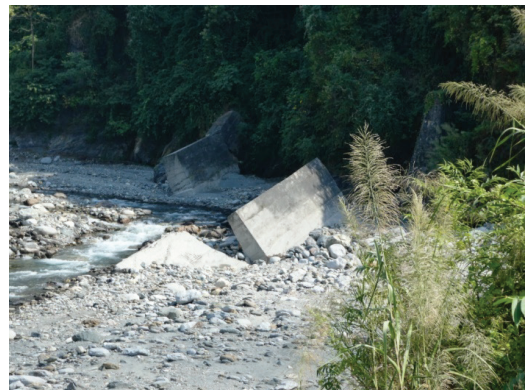
Figure 1:Groynes constructed (and subsequently destroyed by high river flows) in an unsuccessful attempt to train the river away from the BFAL factory site

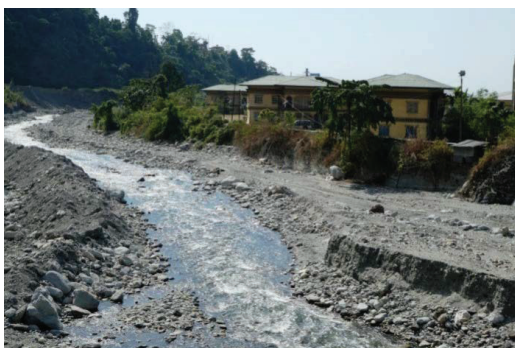
Figure 2: BFAL housing colony is constructed on flood plain about one km below the factory site

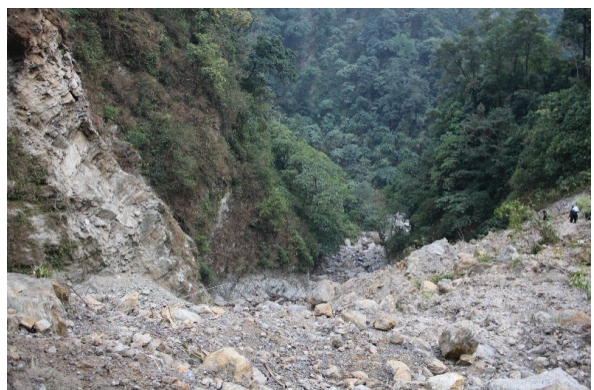
Figure 8: landslide along Jumja river

highly crushed and crenulated in nature and found to be the most incompetent unit. The crushed carbonaceous part when dissolved in rain water during monsoon adds volume and flows along the down slope leaving deep gully erosions (Figure 8).

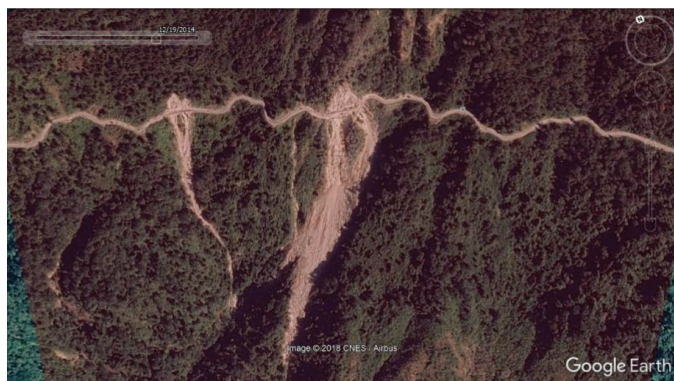
Figure 12: overview of debris dumped along Phuentsholing-Thimphu road

The debris from road construction and maintenance are mostly dumped below the road (Figure 12) without proper guidance and care. The debris and boulders along the steep terrain often fall into the streams and rivers and increase the sediment load contributing to heavy bed loads along the downstream. Sometimes, during the peak rainy season, the

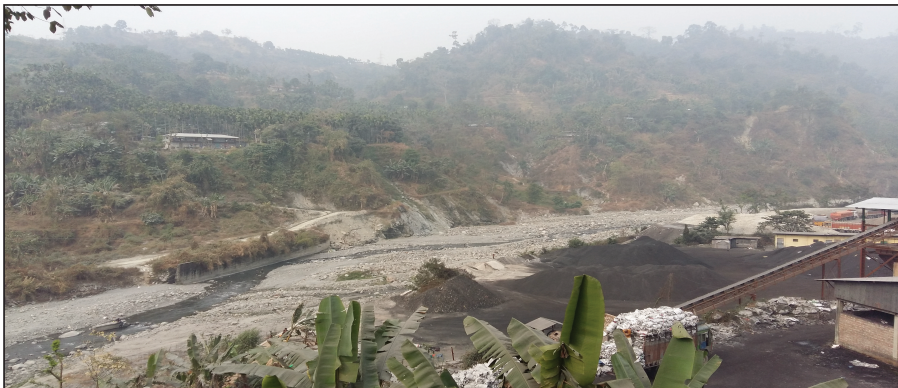
Figure 16: Photo showing waste dumped from factories along the river bank (right) and affected road to Phurbaling village(left)

- iii. The other concern is the dumping of waste from industries on the side of Barsa river and diverts the course of the river and affects the slope on the other side where Phurbaling village is located. While the impact of the dumping on aquatic life is not known, but the waste is directly polluting the Barsa river (Figure 17).

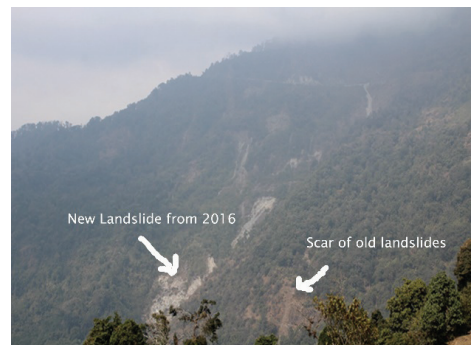
Figure 11: New and old landslides

Landslides are the major issues along the tributary. There are about eight major landslides active along the river. In the initial scoping report it was reflected as five as this was the number provided to us by the Industries people, however in this report it is reflected as eight because there are eight major slides contributing to the river at different points even though some slides originate from same point. Some landslides from past rehabilitated while new ones have surfaced along the river (figure 5).

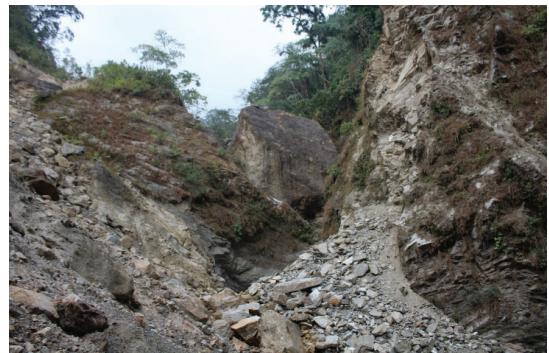
Figure 12: Landslide 1

In light of the above, the landslide 1 is active since 2000. The Flash flood event in 2000 was believed to be triggered by this slide. There is a huge boulder on the river path at this site and it has the potential to create dams in the future if there are mass movements upstream. The movement of fishes and other aquatic animals from downstream probably cannot go beyond the point as the landslide has created a blockage.

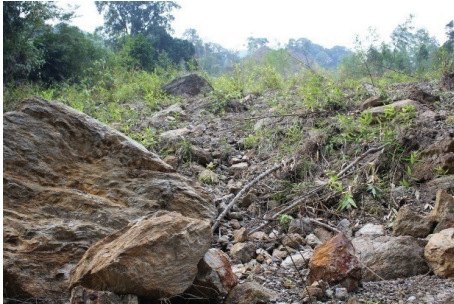
Figure 13: Landslide 2

This landslide appeared since 2016. While it originates from the same place that of landslide 1, it affects the river about few hundred meter downstream.

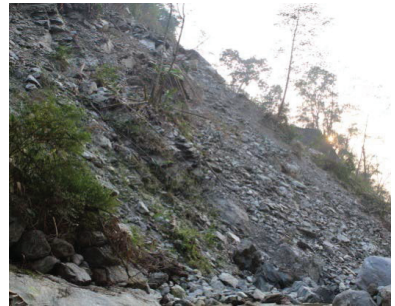
Figure 14: landslide 3

This used to be a small slide before but picked up size since 2016.

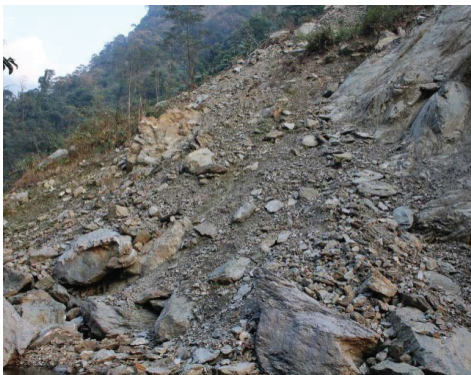
Figure 15: Landslide 4

This landslide affects the river below landslide 3 and it is active since 2016.

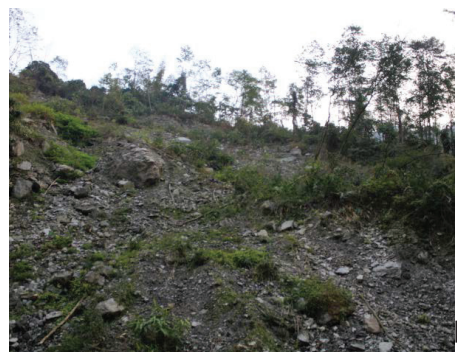
Figure 16: Landslide 5

This slide was there since 2000 and it rehabilitated naturally once but started sliding again in 2013. There is a small stream from this landslide.

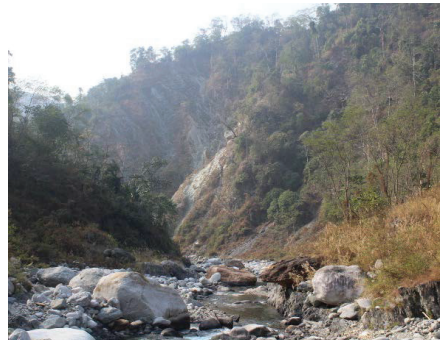
Figure 18: landslide 7

This landslide is active and located beside the confluence of Jumja and Kamji rivers

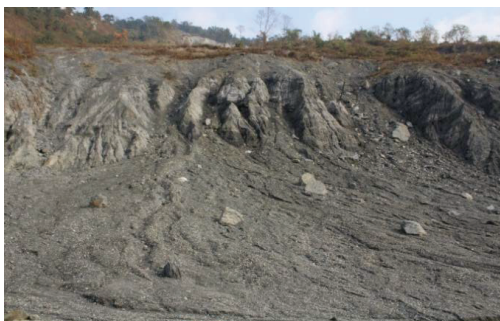
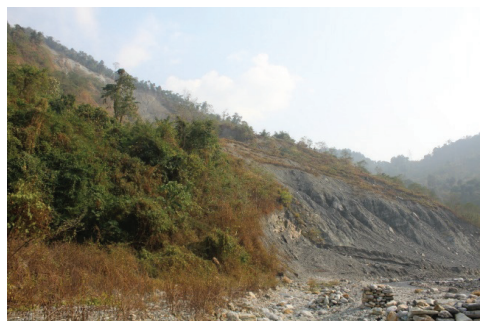
Figure 19: Landslide 8

This is a huge landslide Above Bhutan Silicon Manufacturing Private Limited. The slide is active since 2013 this slide has choked the river with debris in 2012-2013

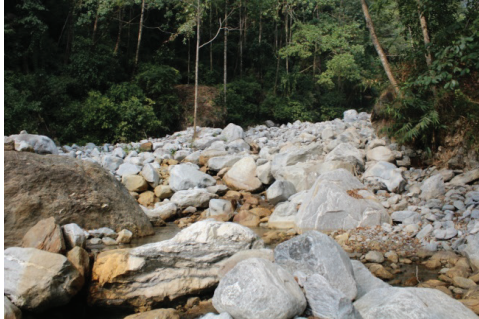
Figure 20: Sight of clean boulders

The risk from the landslides are further amplified by the presence of boulders along the river path. Throughout river path, the riverbed is filled with very clean boulders of various sizes (figure 14). Some of these boulders have potential of blocking the river and forming dams if there is high debris flow from upstream. Formation of such dams would have devastating effects downstream.

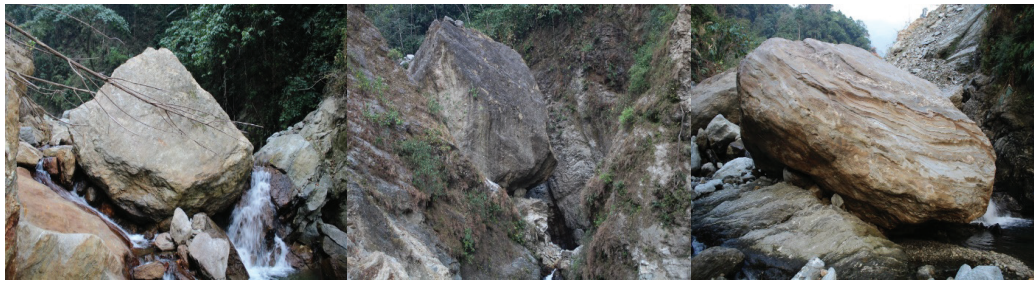
Figure 21: Boulders capable of blocking the river

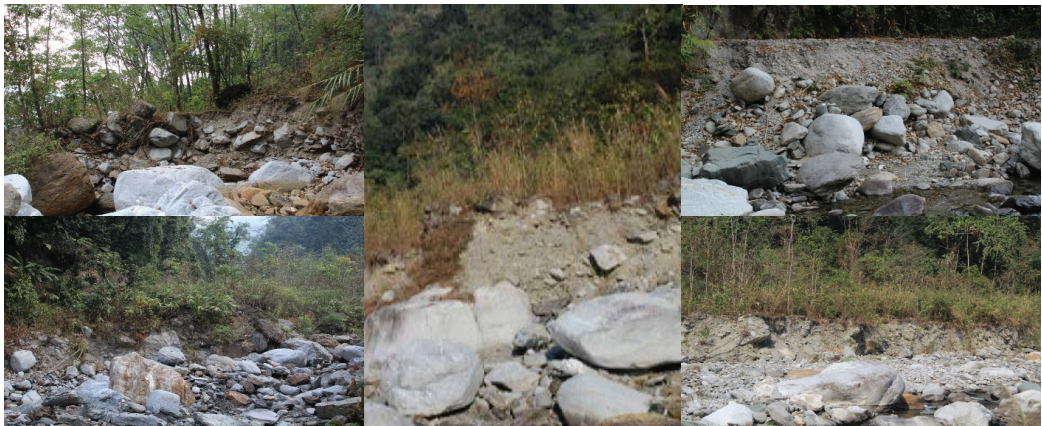
Figure 22: Sight of riverbed levels in 2000 and present

As visible in figure 16, the riverbed level in the year 2000 is much higher than the current level. It is obvious that the aggrading event downstream is the direct result of these changes in riverbed morphology upstream and it has at least cost industries Nu.03 million annually.
