# **Wangchu (Upper) Watershed Management Intervention Report**

**Jigme Dorji National Park & Watershed Management Division**  
**Department of Forests and Park Services**  
**Ministry of Agriculture and Forest**

Jamtsho, Y., Leki., Dorji, S., Phuntsho, W. and Jamtsho, S. (2022). Wangchu (Upper) Watershed Management Intervention Report, Jigme Dorji National Park, Department of Forests and Park Services, Ministry of Agriculture and Forest, Gasa, Bhutan.

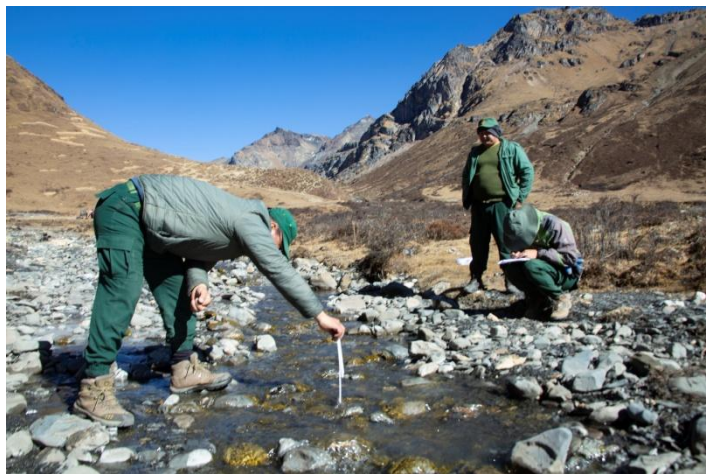
Figure 5: Field data collection

During the field investigation, transect walks were done in watershed area to garner vital information's to access the health of watershed following Watershed Classification Guideline 2016. Watershed condition was assessed based on consideration of up to 28 criteria grouped into four categories; Biophysical, socio-economic, climatic and demographic. Furthermore, discharge measurements and GPS points were collected for all streams that drain water into Wangchu.

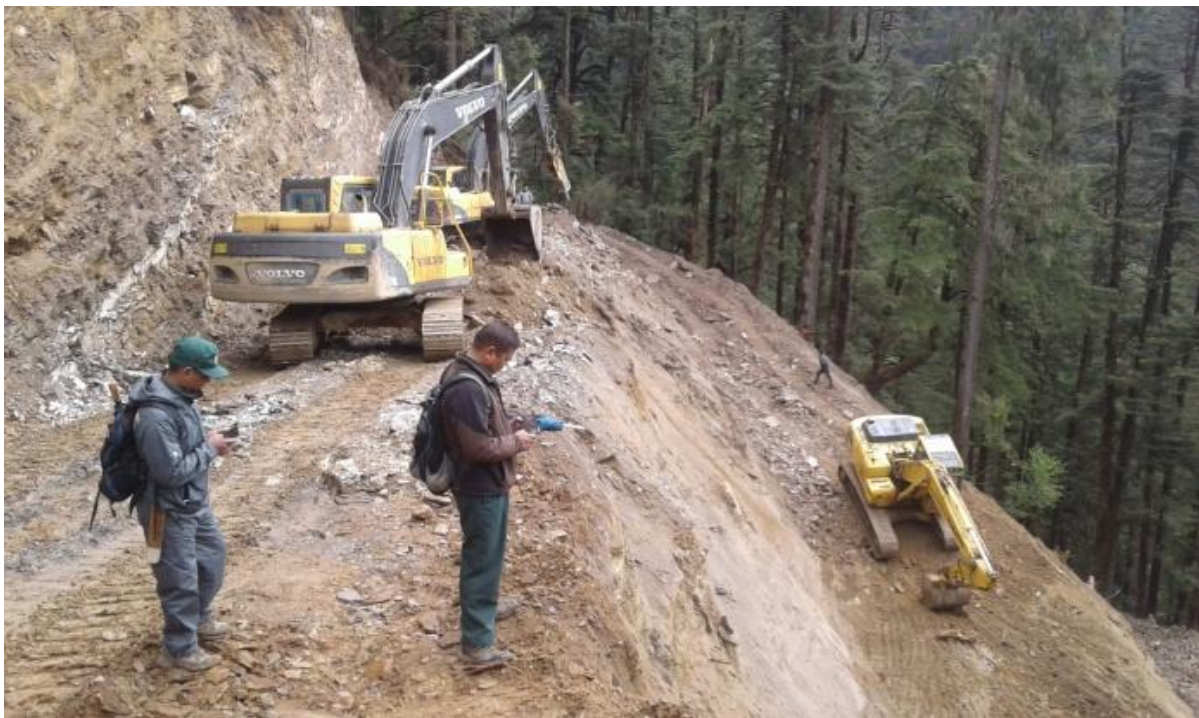
**Figure 10: Construction of Barshong GC road**

The recently constructed 25 km Barshong GC road runs parallel to Wangchhu and cuts through many streams and tributaries, which ultimately flows into Wangchhu. The entire stretch of road falls a few meters to less than 200 meters above the Wangchhu, where construction of road involved huge excavation of earth along the steep terrain and blasting of rocky outcrops. The debris and boulders from the excavation and blasting sites often fall into Wangchhu and nearby streams and increase the sediment load contributing to heavy bed loads along the downstream. Sometimes, during the peak rainy season, the debris including boulders dam the streams and tributaries and ultimately triggers landslide dammed outburst floods. This will not only contaminate the water bodies but cause flooding of the settlement and damaging of properties situated in the downstream areas.

Roads were found to be major sources of erosion in the watersheds because of poor drainage and exposed cut and fill slopes. Activities to improve cross drainage and rehabilitate cut and fill areas will decrease erosion and consequent stream sedimentation.

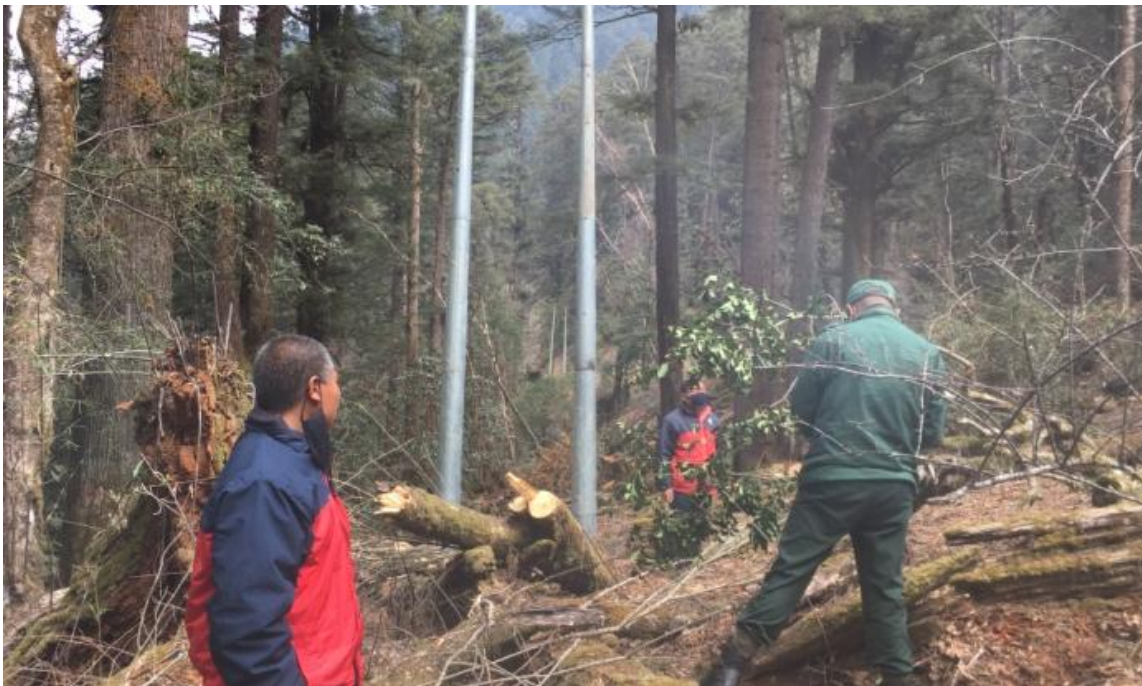
**Figure 11: Felling of trees along electrical transmission line**

The construction of 15.37km Barshong transmission line has damaged large swathes of forest across the watershed. In order to open enough space for 11KV line to pass through, a minimum of 6 meters of Right of Way (RoW) was created. As a result a total of 800 trees and poles of various species were felled within the corridor. A clearing felling of 6 meters corridor through the alignment has exposed soil to erosion and also leads to change in vegetation composition. Moreover, most of the felling occurred along the steep slopes and difficult terrains. Therefore, in geologically unstable and landslide prone areas, these kinds of practices had led to erosions and aggravated the situation in the active landslide areas. Resulting in washing away of fine soil during rainy season and causing blockage of natural and manmade drains and subsequent flooding into Wangchhu and nearby streams.

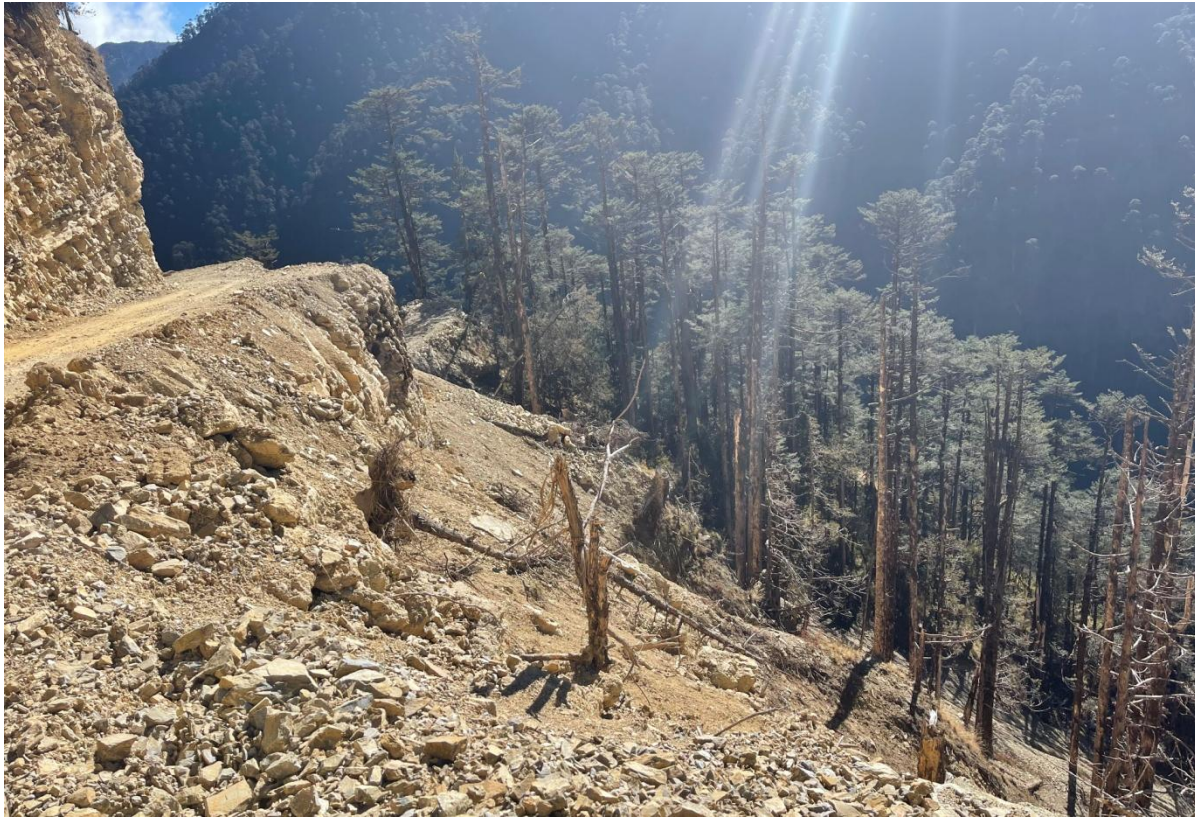
**Figure 12: Deep excavation along Dodena-Barshong road**

Deep excavation and drilling during road construction may result in rupture or disappearance of ground water tables, resulting in reduction of the volume of water flow and eventual drying up of the streams. This will be a major issue for the people residing downstream, especially Thimphu Thromde inhabitants, who currently depend on Wangchhu for drinking water. Spillage of hazardous chemicals from the excavator, blasting materials and drilling machine may contaminate the water bodies, mainly streams and rivers flowing below the roads and the nearby ground water, and may thus render them unsafe for human consumption and domestic uses. Seeing that almost 50% of the Thimphu Thromde inhabitants use their drinking water from Wangchhu, such contamination will have severe impact and may even exacerbate the shortage of water available for human consumption where Wangchhu is predicted to meet the growing drinking water demand for next 30 years. In the

worst case scenario, there will be no drinking water source for half of Thromde population, and in such case, there is a dire need to identify drinking water source in other areas which will incur huge financial burden on the government.

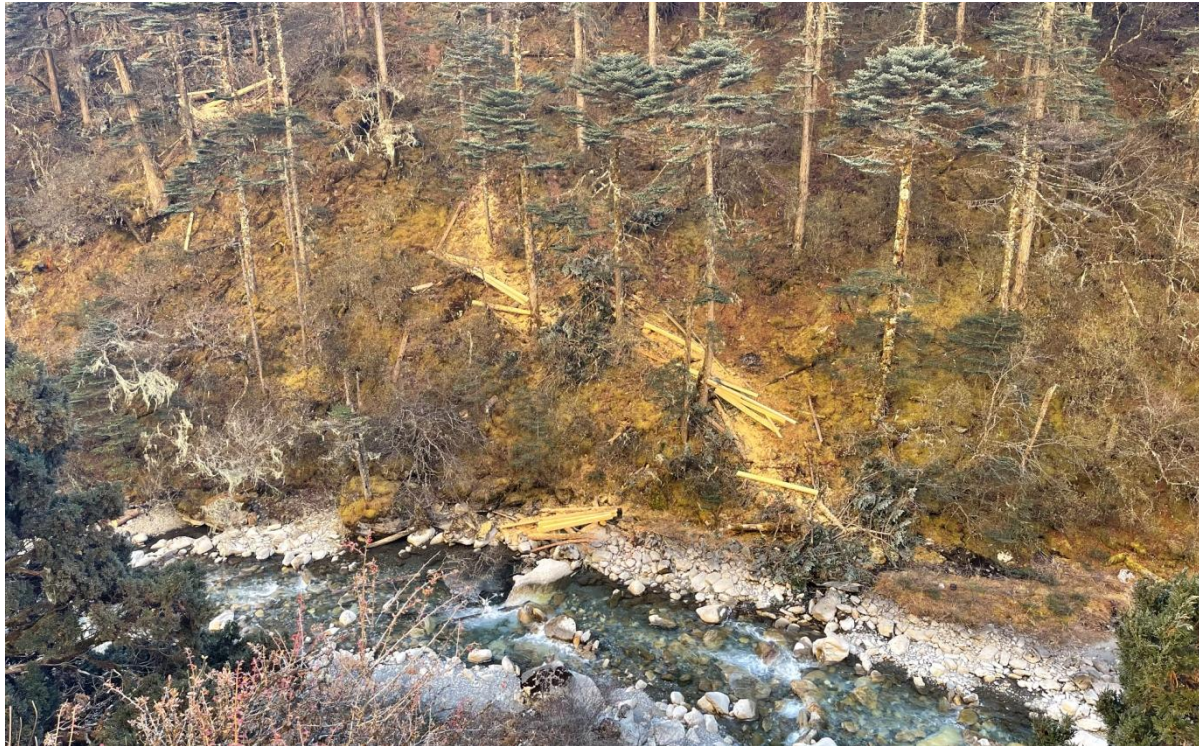
**Figure 13: Forest degradation in watershed area**

The main drivers of forest degradation in the watershed are transmission line and road construction, harvesting of timber and fire wood, cattle grazing and natural hazards, such as landslides. The harvesting of timbers for Lingzhi Dzong construction and clearing of forest for Barshong road construction have heavily degraded some areas within the watershed. For instance, the ongoing Naro GC road construction is estimated to clear 3672 trees and around 24,000 Cft of timber has been allotted for Lingzhi Dzong construction. It is evident that pressure on the forests is high and has resulted in them becoming degraded where population density is highest. With the increase of human population inside the watershed, the demand for use of natural resources is expected to increase, which will place additional pressure on the remnant forests.

Forest condition has a direct effect on the provision of watershed goods and services. Degraded forests, particularly when huge chunk of forest is cleared and deep digging or excavation is carried out, which may trigger soil erosion or land slide in the area. Consequently, it may cause stream

sedimentation and pollution, as well as depletion of plant nutrients. In addition, degraded forests lack resilience and are less able to withstand shocks, such as those associated with climate change, than forests in sound ecological condition.

The watershed condition depends on the health of the forest, so one way of mitigating the degraded forest is by enrichment plantation. The success of the plantation hinges on the quality of seedlings. Seedlings of native species belonging to primary succession stage of the nearby forest ecosystem shall be collected from nearby nurseries. The plantations need to be well taken care in their initial

stage with proper fencing and timely watering and addition of manure. The process of natural succession is highly probable due to existence of lush forest cover in the watershed area. Moreover, the sustainable harvest of the forest is key for maintaining the watershed condition so development of LFMP especially in tree marking areas is highly recommended.

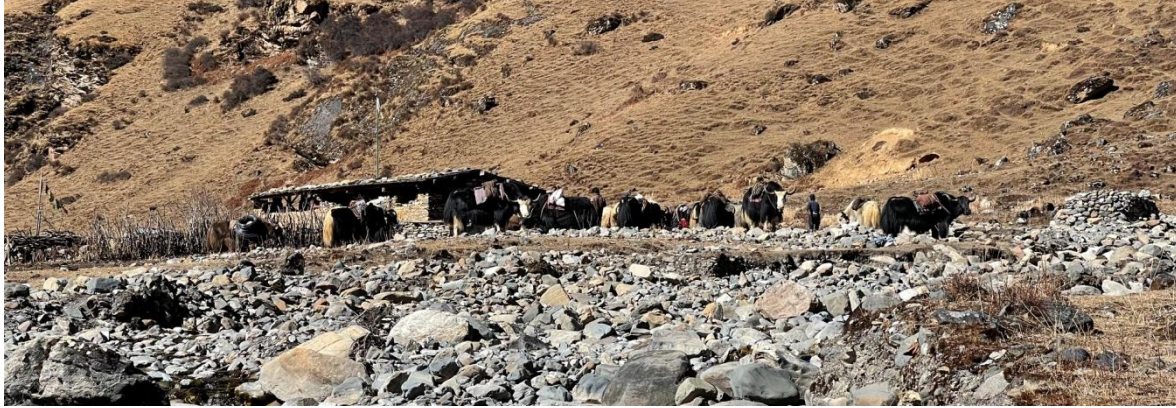
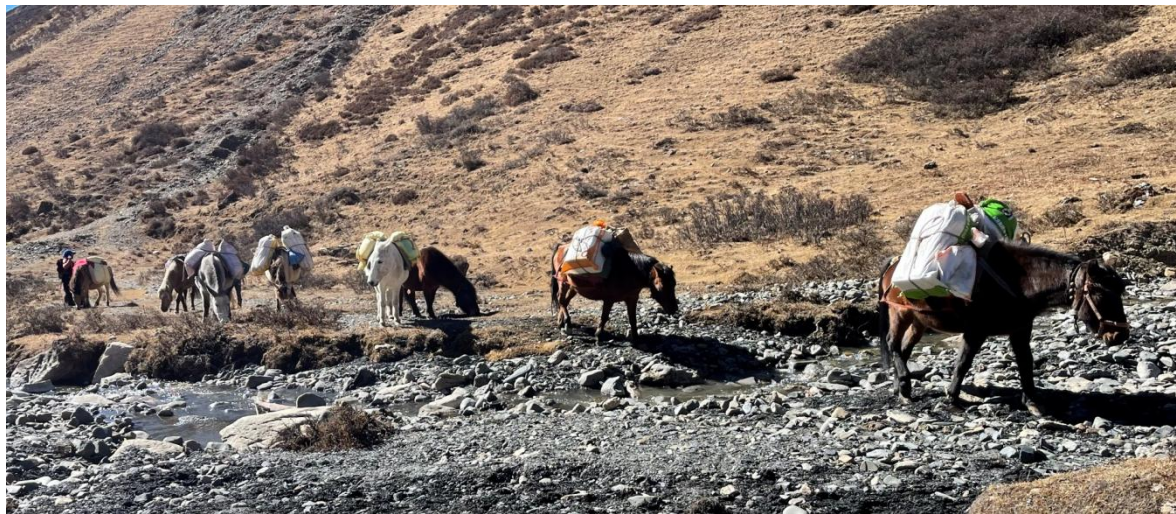
These watersheds being the main summer grazing ground for yak herders, it is evident that grazing may have adverse effect on tree regeneration as it coincides with tree regeneration season which usually happen in summer, when the weather is conducive for germination. Moreover, it has been observed that the rate of regeneration was very poor in areas heavily grazed by domestic cattle and where the cattle density is high. In alpine forest, the ground vegetation directly correlates to the rate of surface runoff, less ground cover means more surface runoff resulting in heavy siltation of stream and riverbed. The Naro Gewog alone has about 1488 heads of livestock. The Lingzhi Gewog has total of 3407 heads of livestock (Dendup et al. 2021) from which majority of them also come to graze in Wangchu watershed area.

**Figure 14: Yak herd near Majaphu stream**

**Figure 15: Herd of horses used for transportation of goods in watershed area**

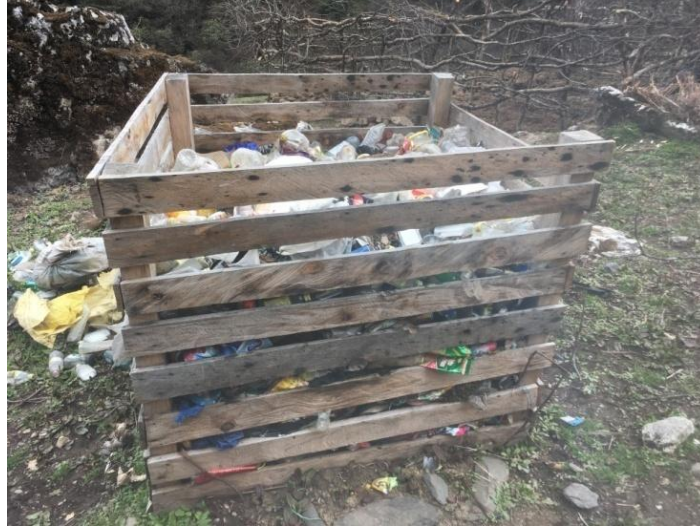
The number of visitors in the park has tripled in the last few decades including construction workers, both regional and international tourist, government officials and illegal poachers, as a result, there is an accumulation of solid wastes (such as plastic bags, liquor bottles, tarpaulins, concretes, steel, wooden scaffolding, and feces) and liquid wastes (such as used or spilled grease, mobile, and diesel oil) from the construction sites. These wastes will in turn lead to series of negative impacts (if not managed properly) such as loss of aesthetic beauty of the surrounding, contamination of the soil and water bodies, and soil erosion.

**Figure 16: Waste collected and dumped at several sites inside the watershed area. This happened as there are no collectors even at the road head point.**

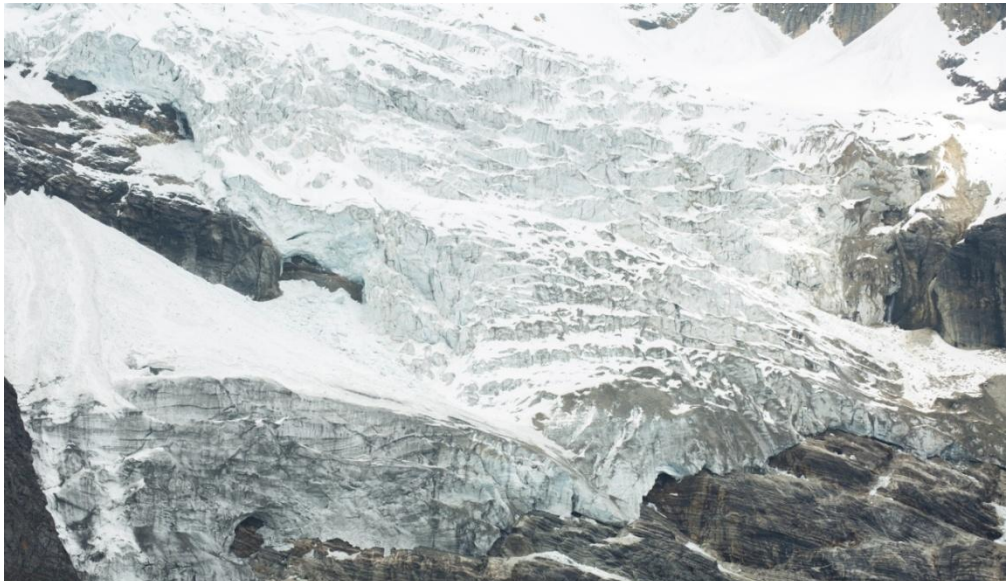
**Figure 17: Glaciers retreating (ocular observation) as compared to past few years in the watershed area**

The key observation from some locals was that a spring tended arrive later in the year, rapidly transition to summer monsoon, followed by long fall and late onset of winter. Thus the entire seasonal (temperature) calendar seems to have moved forward. This change in temperatures has been accompanied by change in snowfall, making snowfall less and unpredictable. This would also change the timing and volume of water discharge into rivers and streams within the watersheds. Moreover, groundwater discharge in alpine headwaters sustains baseflow in rivers originating from these watersheds, which is critically important for aquatic habitats, run-of-river hydropower generation, and downstream water supply. Therefore, monitoring of seasonal snow is important to understand the impact of climate change on water availability for continuous drinking water supply for the downstream settlements especially Thimphu city inhabitants that draw water from Wangchhu river. In addition, information about temporal and spatial distribution of seasonal snow cover is an important indicator of climate monitoring. Many recent studies on snow cover variability both at the global and region scale have shown a decline in snow cover area, particularly in spring season.
