## **Monitoring of Landslide at Tsimasham, Reldri and Box-Cutting using GPS**

Department of Geology and Mines

Monitoring Period: August 2015 to May 2017

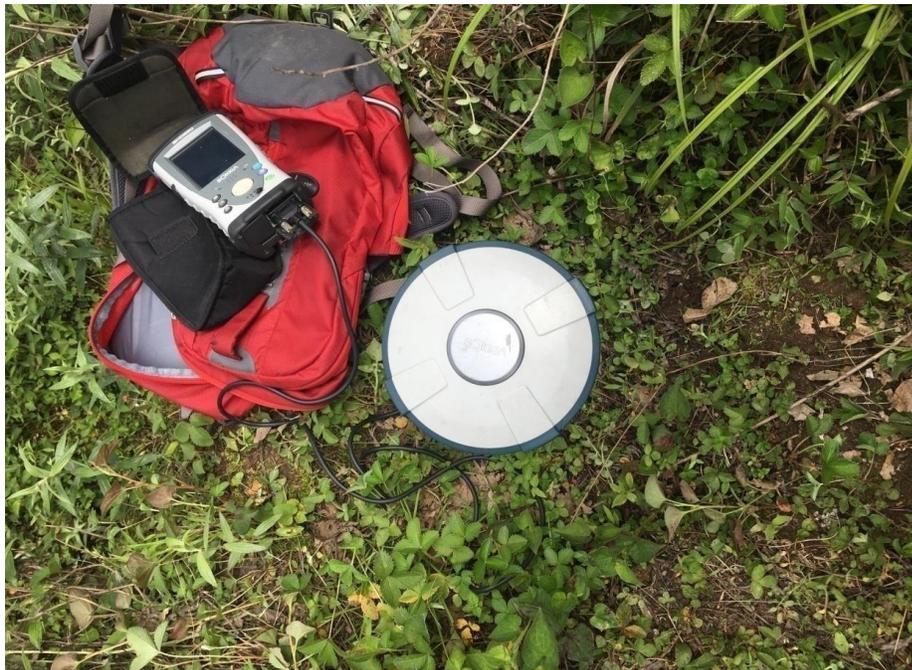
*Figure 5. GPS used for the observation of point at Tsimasham.*

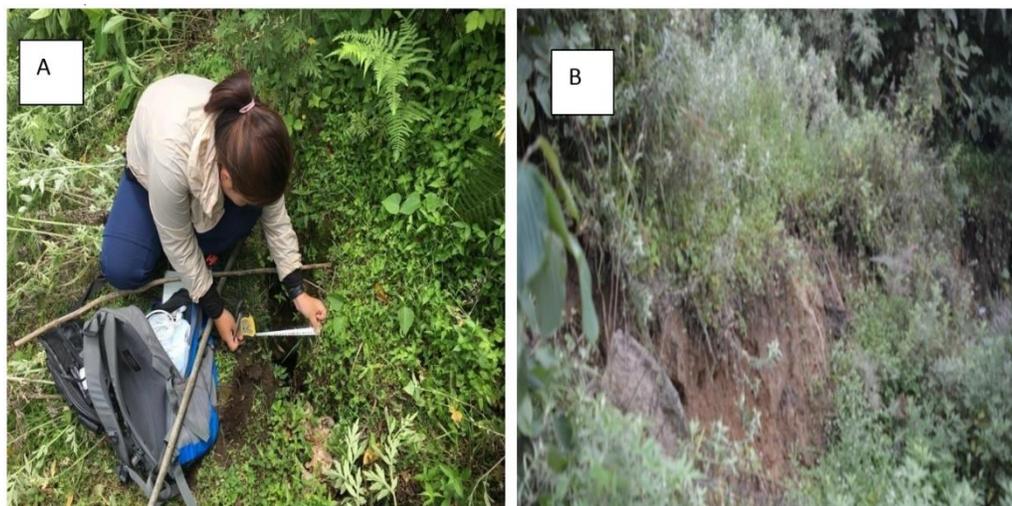
During the first observation at Tsimasham, no tension cracks were observed at the crown of the landslide but subsidence of the ground of this landslide was observed during fieldwork. Tilted trees are common phenomenon indications of the landslide in the area. However, during second observation in May 2016, three new tension cracks have developed on the crown of the landslide (Figure 9). The location and dimension of individual tension is given in Table 5. In May 2017, the tension located within geographical coordinate 27.10250° E: 89.53556° T1 and T3 N: 27.10247° E: 89.53534° has displaced with slip face angle ranging from 65-70° (Figure 9) while T2 located at N: 27.10251° E: 89.53541 have varied by width and depth of 0.5m and 0.2m respectively from the previous dimension.

*Figure 9. Tension crack developed on the crown of the landslide at Tsimasham (Picture taken in May 2016) and (B) showing displaced crack (Picture taken in May 2017).*

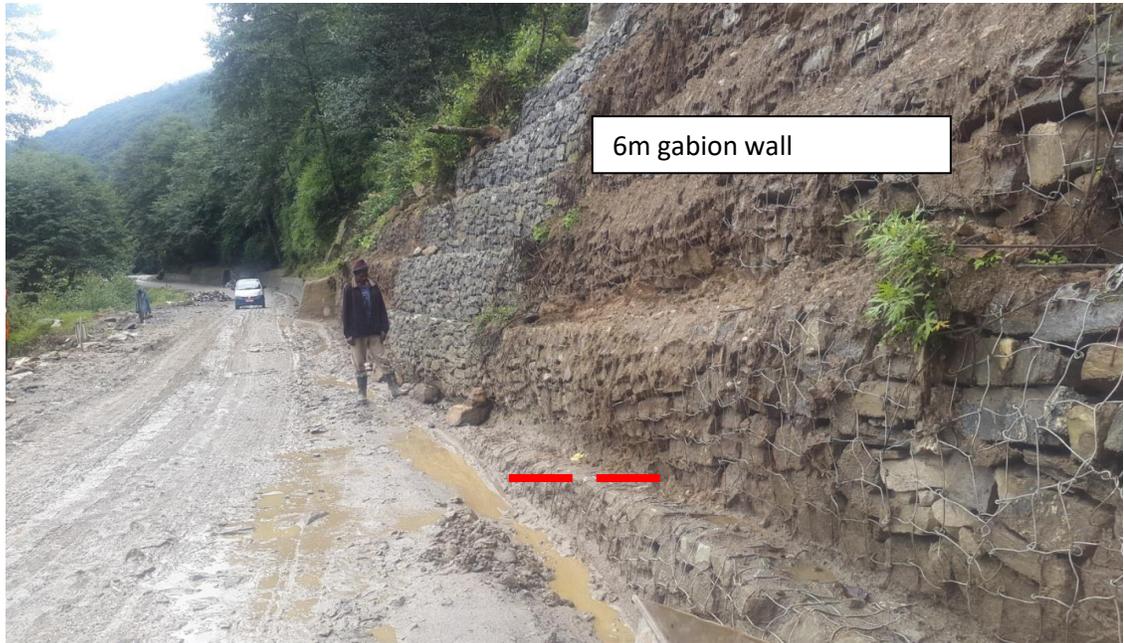
Figure 10. The sinking of Gabion wall indicating active mass movement at Tsimasham landslide (Picture taken in September 2016)

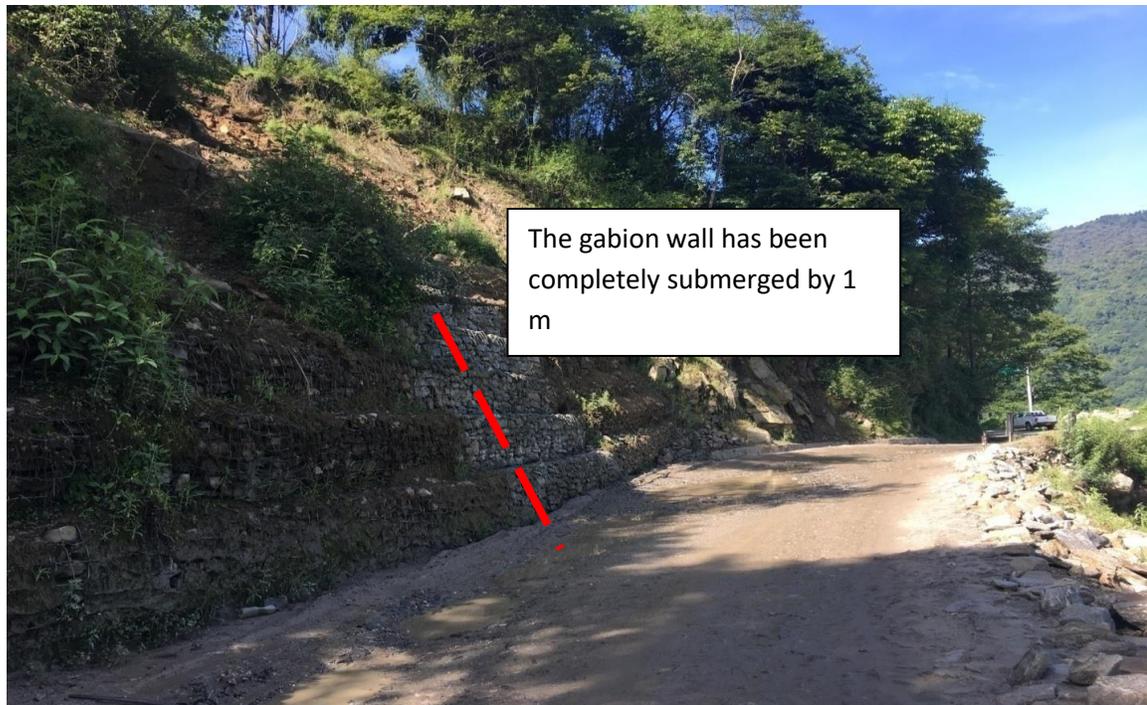
Figure 11. Gabion wall has completely submerged by 1 m at Tsimasham landslide. Refer Figure 10 for comparison (Picture taken in May 2017).

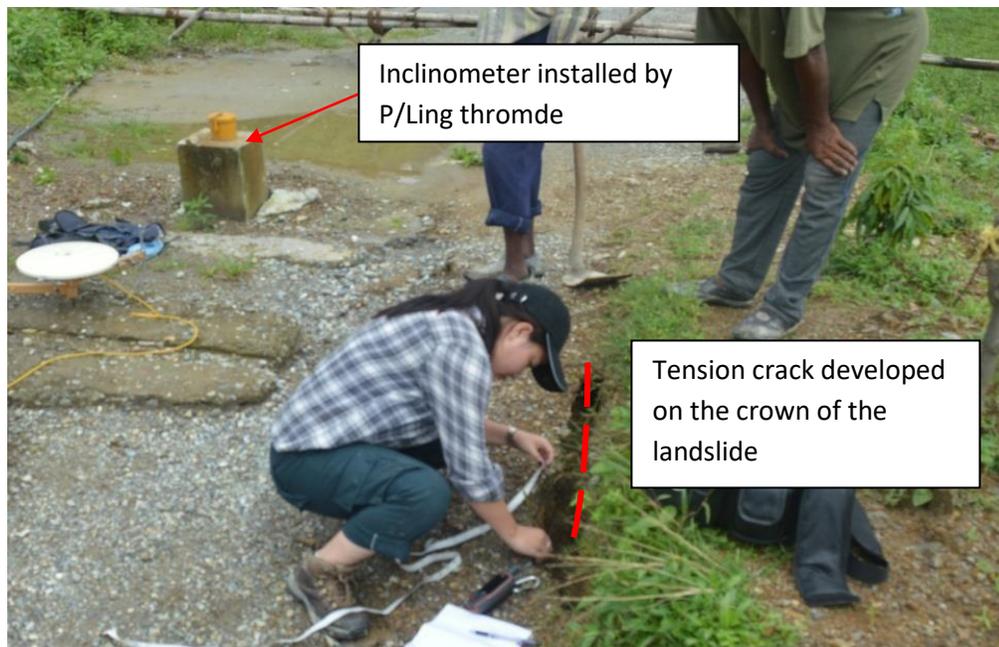
At Reldri, three tension cracks were observed during the first landslide monitoring (Figure 11). All the tension cracks were developed on the crown of the landslide specifically at the crown of the landslide. The coordinate of the tension cracks is T1 N:26°50'52.4" E:89°24'16.1" E:406m, T2 N:26°50'52" E:89°24'16" E:405 m and T3 N:26°50'52.7" E:89°24'16.1" E:411m. The dimension of each crack is given in Table 5. The inclinometer which was installed on the crown of the landslide by French consultancy under NAPA II project has been washed away along with the displacement of crack. In May 2016, it was observed that all the tension had been washed away (Figure 12) and as of May 2017, no tension has been formed in the study area. Moreover, it is observed that there is no lateral extension of the slide but active mass movement along a longitudinal section at coordinate N: 26.84782° E: 89.40452° at an elevation of 403 m is found to very active.

Figure 11. Tension crack developed at Reldri shown by red dotted line (Picture taken in August 2015)

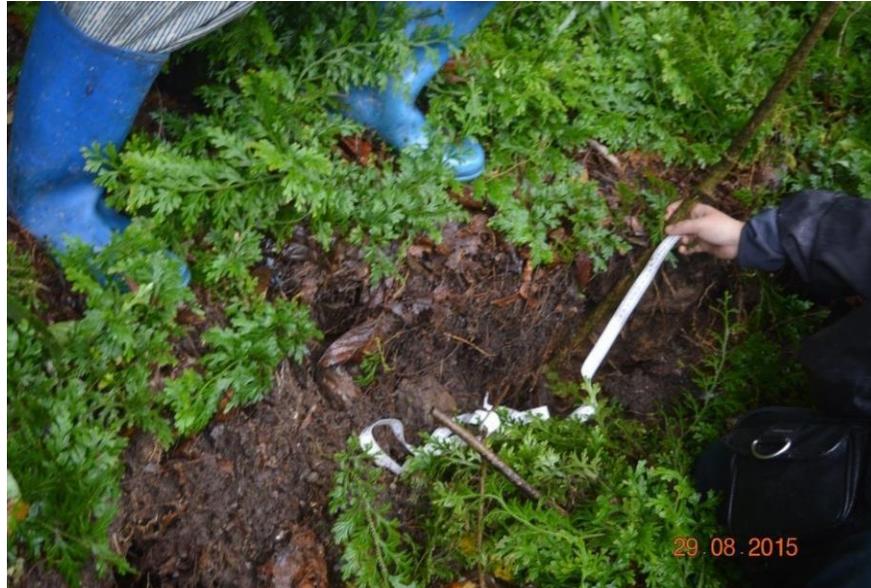
In September 2015, three tension cracks have been developed at the crown of the landslide with wide openings at box-cutting landslide (Figure 13), which rainwater could infiltrate during the rainy season and trigger landslide further. A tension crack has been developed with an average length of 6 m, breadth 5 to 10 cm and depth of about 60 cm in a geographical coordinate T1 N: 26°57'01.2", E:90°31'35.6". In geographical coordinate T2 N: 26°57'01.3", E: 90°31'35.2" a tension crack of length 5m, breadth ranging from 15 to 20 cm and depth 40 cm has been developed. A tension crack T3 having a length of 6m, breadth ranging from 50 cm to 1 m and depth 40 cm has been developed at this coordinate N:26°57'02.3", E:90°31'35.2". However, in May 2016, it was observed that there was variation in dimension by 0.20 width, 0.4 depth in T1, while in T2 3m length, 0.06 m width, depth 1.9m and length 6m, width 1m and D=1.5m in T3. In May 2017, all the three tension cracks have been displaced with a slip face angle ranging from 60-70°.

The surface runoff was observed eroding the materials downhill blocking the National Highway Gelephu-Zhemgang Highway.

Figure 13. Tension crack developed at Box-cutting (Picture taken in August: 2015).
