## Integrated Geo-Hazard Risk Assessment of Critical Barsa Watershed under Chukha Dzonkhag

Department of Geology and Mines

Field Season: 2016-2017

This report is in accordance with the work plan of the Department of Geology and Mines, MoEA under the National Adaptation Programme of Action II (NAPA II) Project titled '*Addressing the Risks of Climate-Induced Disasters through Enhanced National and Local Capacity for Effective Actions*', funded by GEF-LDCF through UNDP and implemented by RGOB.

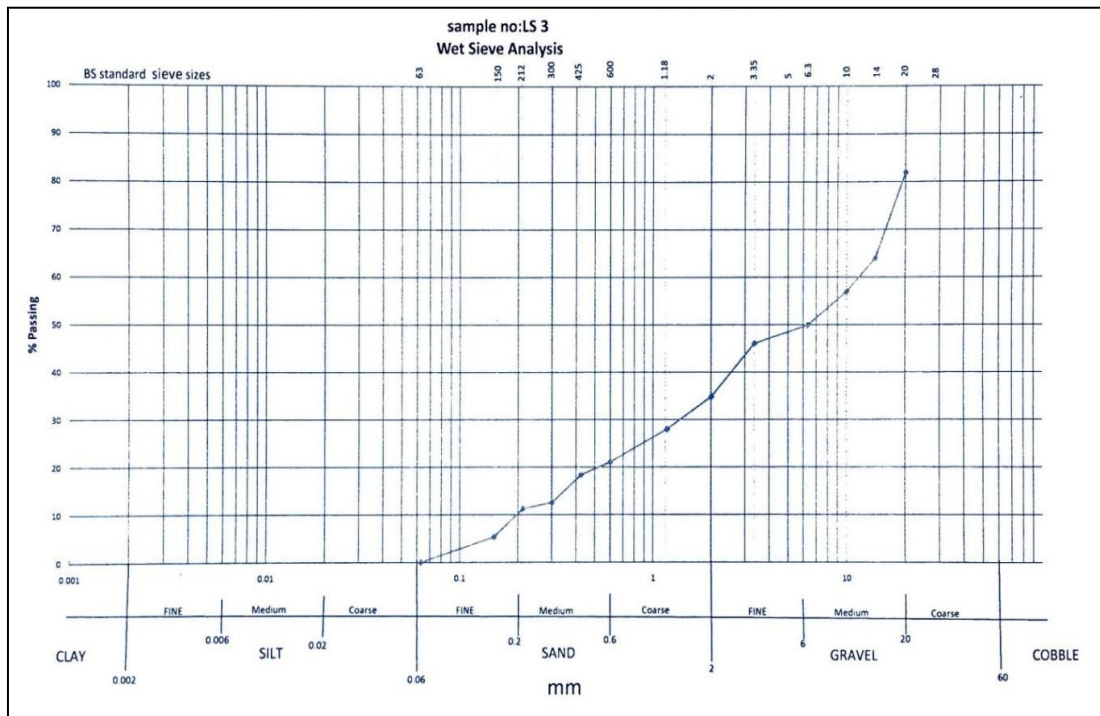
Figure 21. Grain size distribution of LS-3 sample collected from a Slide located opposite to BFAL Colony.

A grab soil sample, LS-3, was collected from this slide to test the particle size distribution in the Geo-tech laboratory. From the grain size graph in Figure 21, the soil distribution curve is not that smooth and concave which could mean that it is a poorly-graded soil. Moreover, the coefficient of curvature value of 0.03 calculated from the grain size distribution graph indicates a possible gap graded soil.

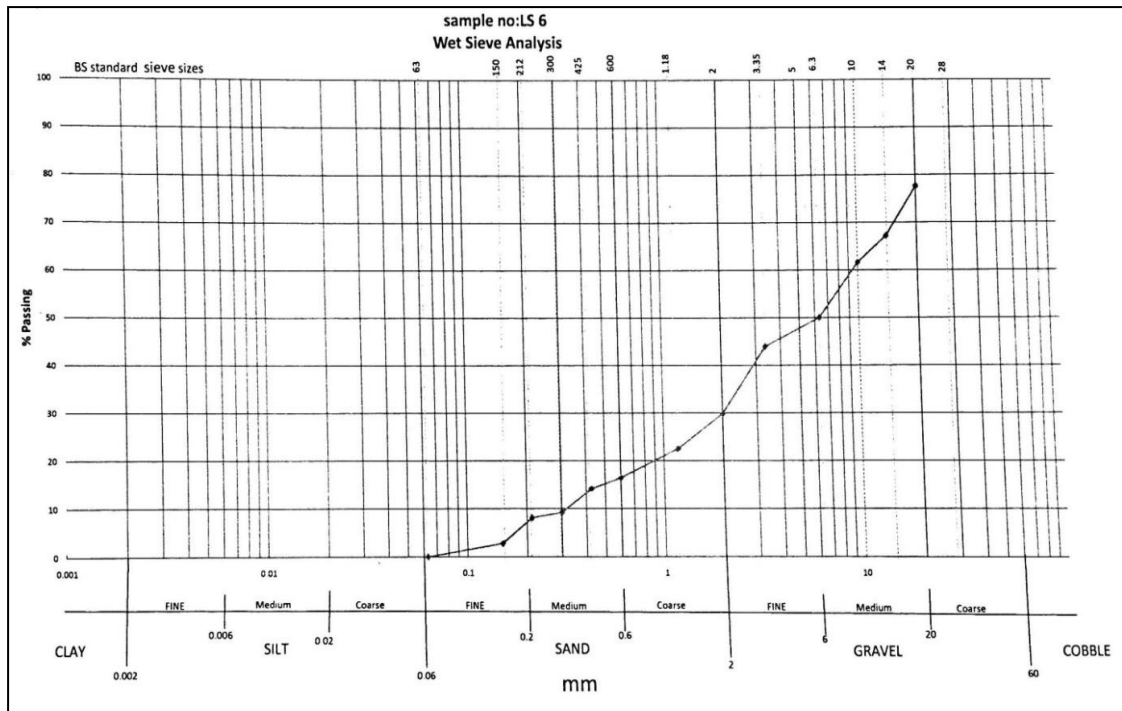
Figure 22. Grain size distribution of LS-6 sample collected from a Slide located at ThuloKhap.

A grab soil sample was collected from this slide at N26°51'8.7" and E89°26'52.0" and tested in the Geo-tech laboratory to understand the particle size distribution. From the grain size graph in Figure 22, the soil distribution curve is not that flat and smooth which could mean that it is a gap graded soil. Moreover, the coefficient of curvature of 0.03, which is less than 0.1 further indicates a possible gap graded soil. Poorly graded or gap-graded soils have good drainage property and with a thick growth of vegetation, there will be less erosion from precipitation. Therefore, this dormant slide seems to be slightly stable from the field and laboratory observations. However, periodic monitoring of this slide is necessary.

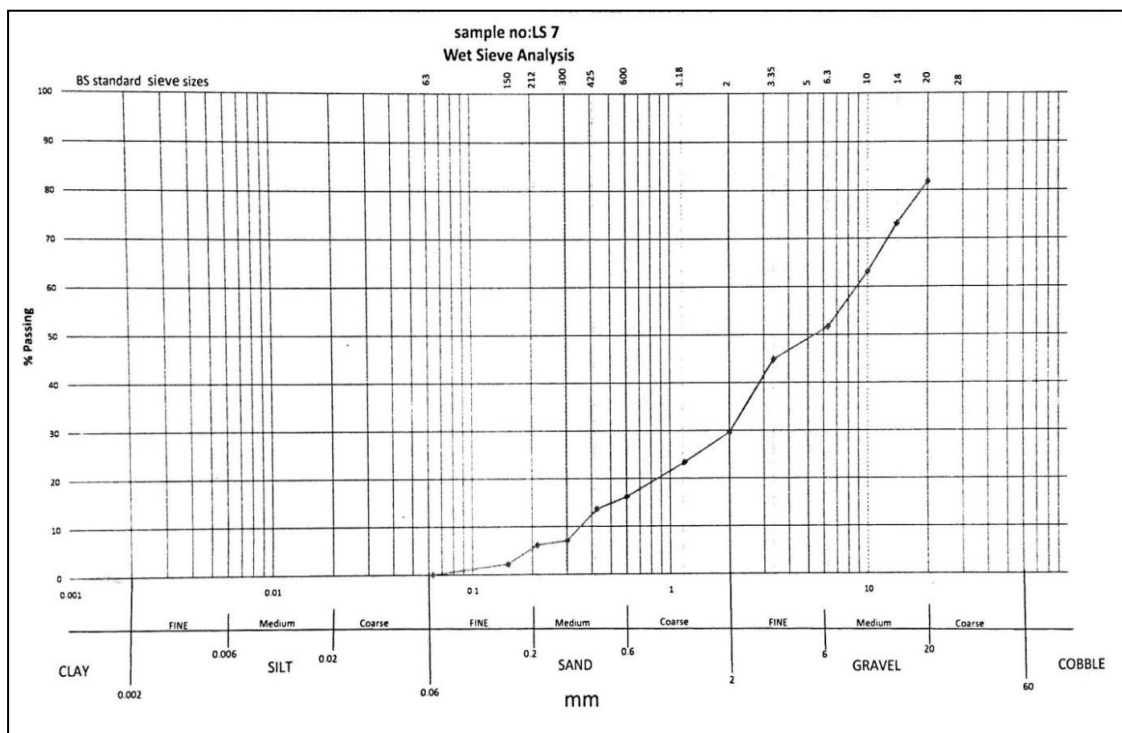
Figure 23. Grain size distribution of LS-7 sample collected from a Slide located in SerikhapPakha.

A grab soil sample was collected from this slide at  $N26^{\circ}51'13.5''$  and  $E89^{\circ}26'50.8''$  and tested in the Geo-tech laboratory to understand the particle size distribution. From the grain size graph in Figure 23, the coefficient of uniformity and curvature were calculated as 24.28 and 0.16 respectively, which meets the conditions of a well-graded soil. Usually, well-graded soils have poorer drainage as compared to poorly

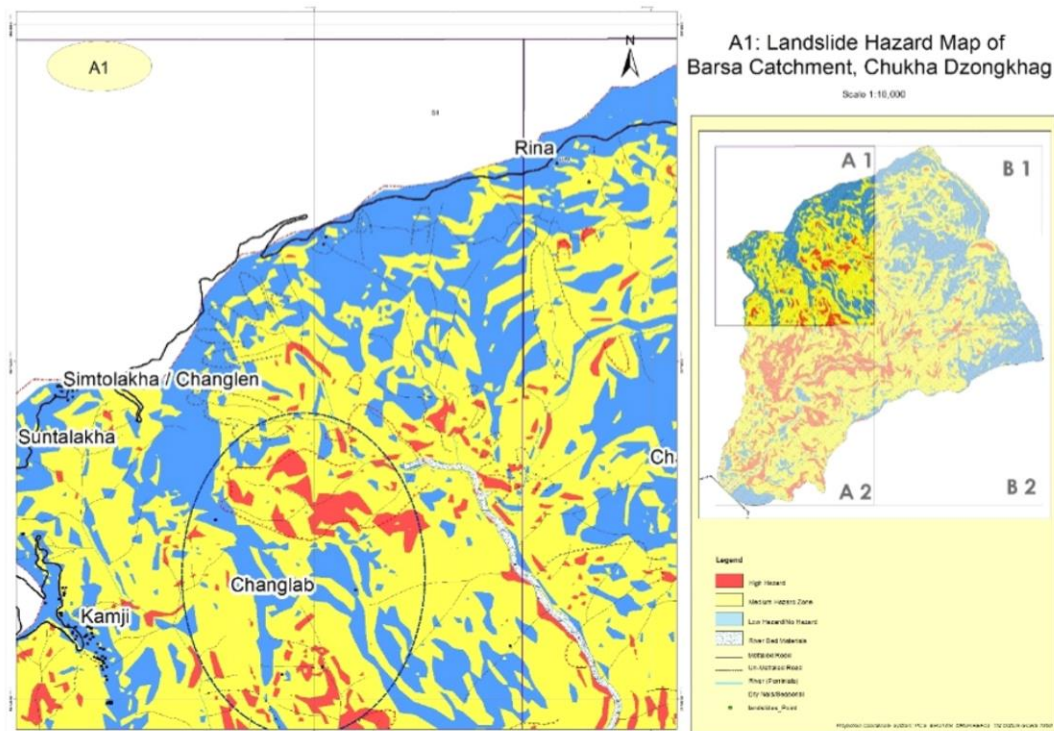
Figure 24. Hazard levels of NW part of Barsa watershed.

The NW part of the watershed hosts villages like Kamji, Suntolakha, Gogkhalaka, Rina, and Tsangling. The area is shown as low hazard area along the tributaries of Barsachu but indicated by high hazard around 300 m away from the Changlep village, as this place falls under grazing area of the communities (Figure 24).

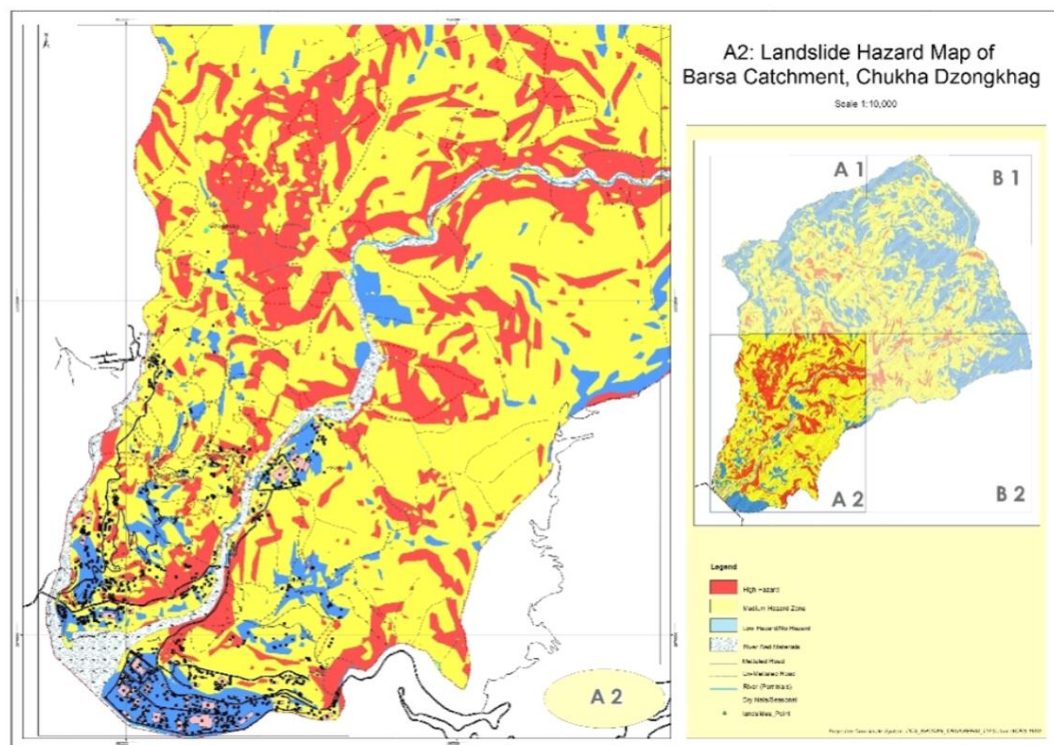
Figure 25. Hazard levels in the SW part of the Barsa watershed.

The SW part of the Barsa watershed, which is predominantly indicated as high and moderately high hazard zone (Figure 25) is occupied by several landslides along ThuloThotney (Kamji Watershed), locally called KalimatiPairo, a tributary of Barsa Chu/river. Several active landslides were also observed in this part. For example, some of the active landslides were found at Pasakha area, above the BFAL colony

and at the left side of the Barsa river.

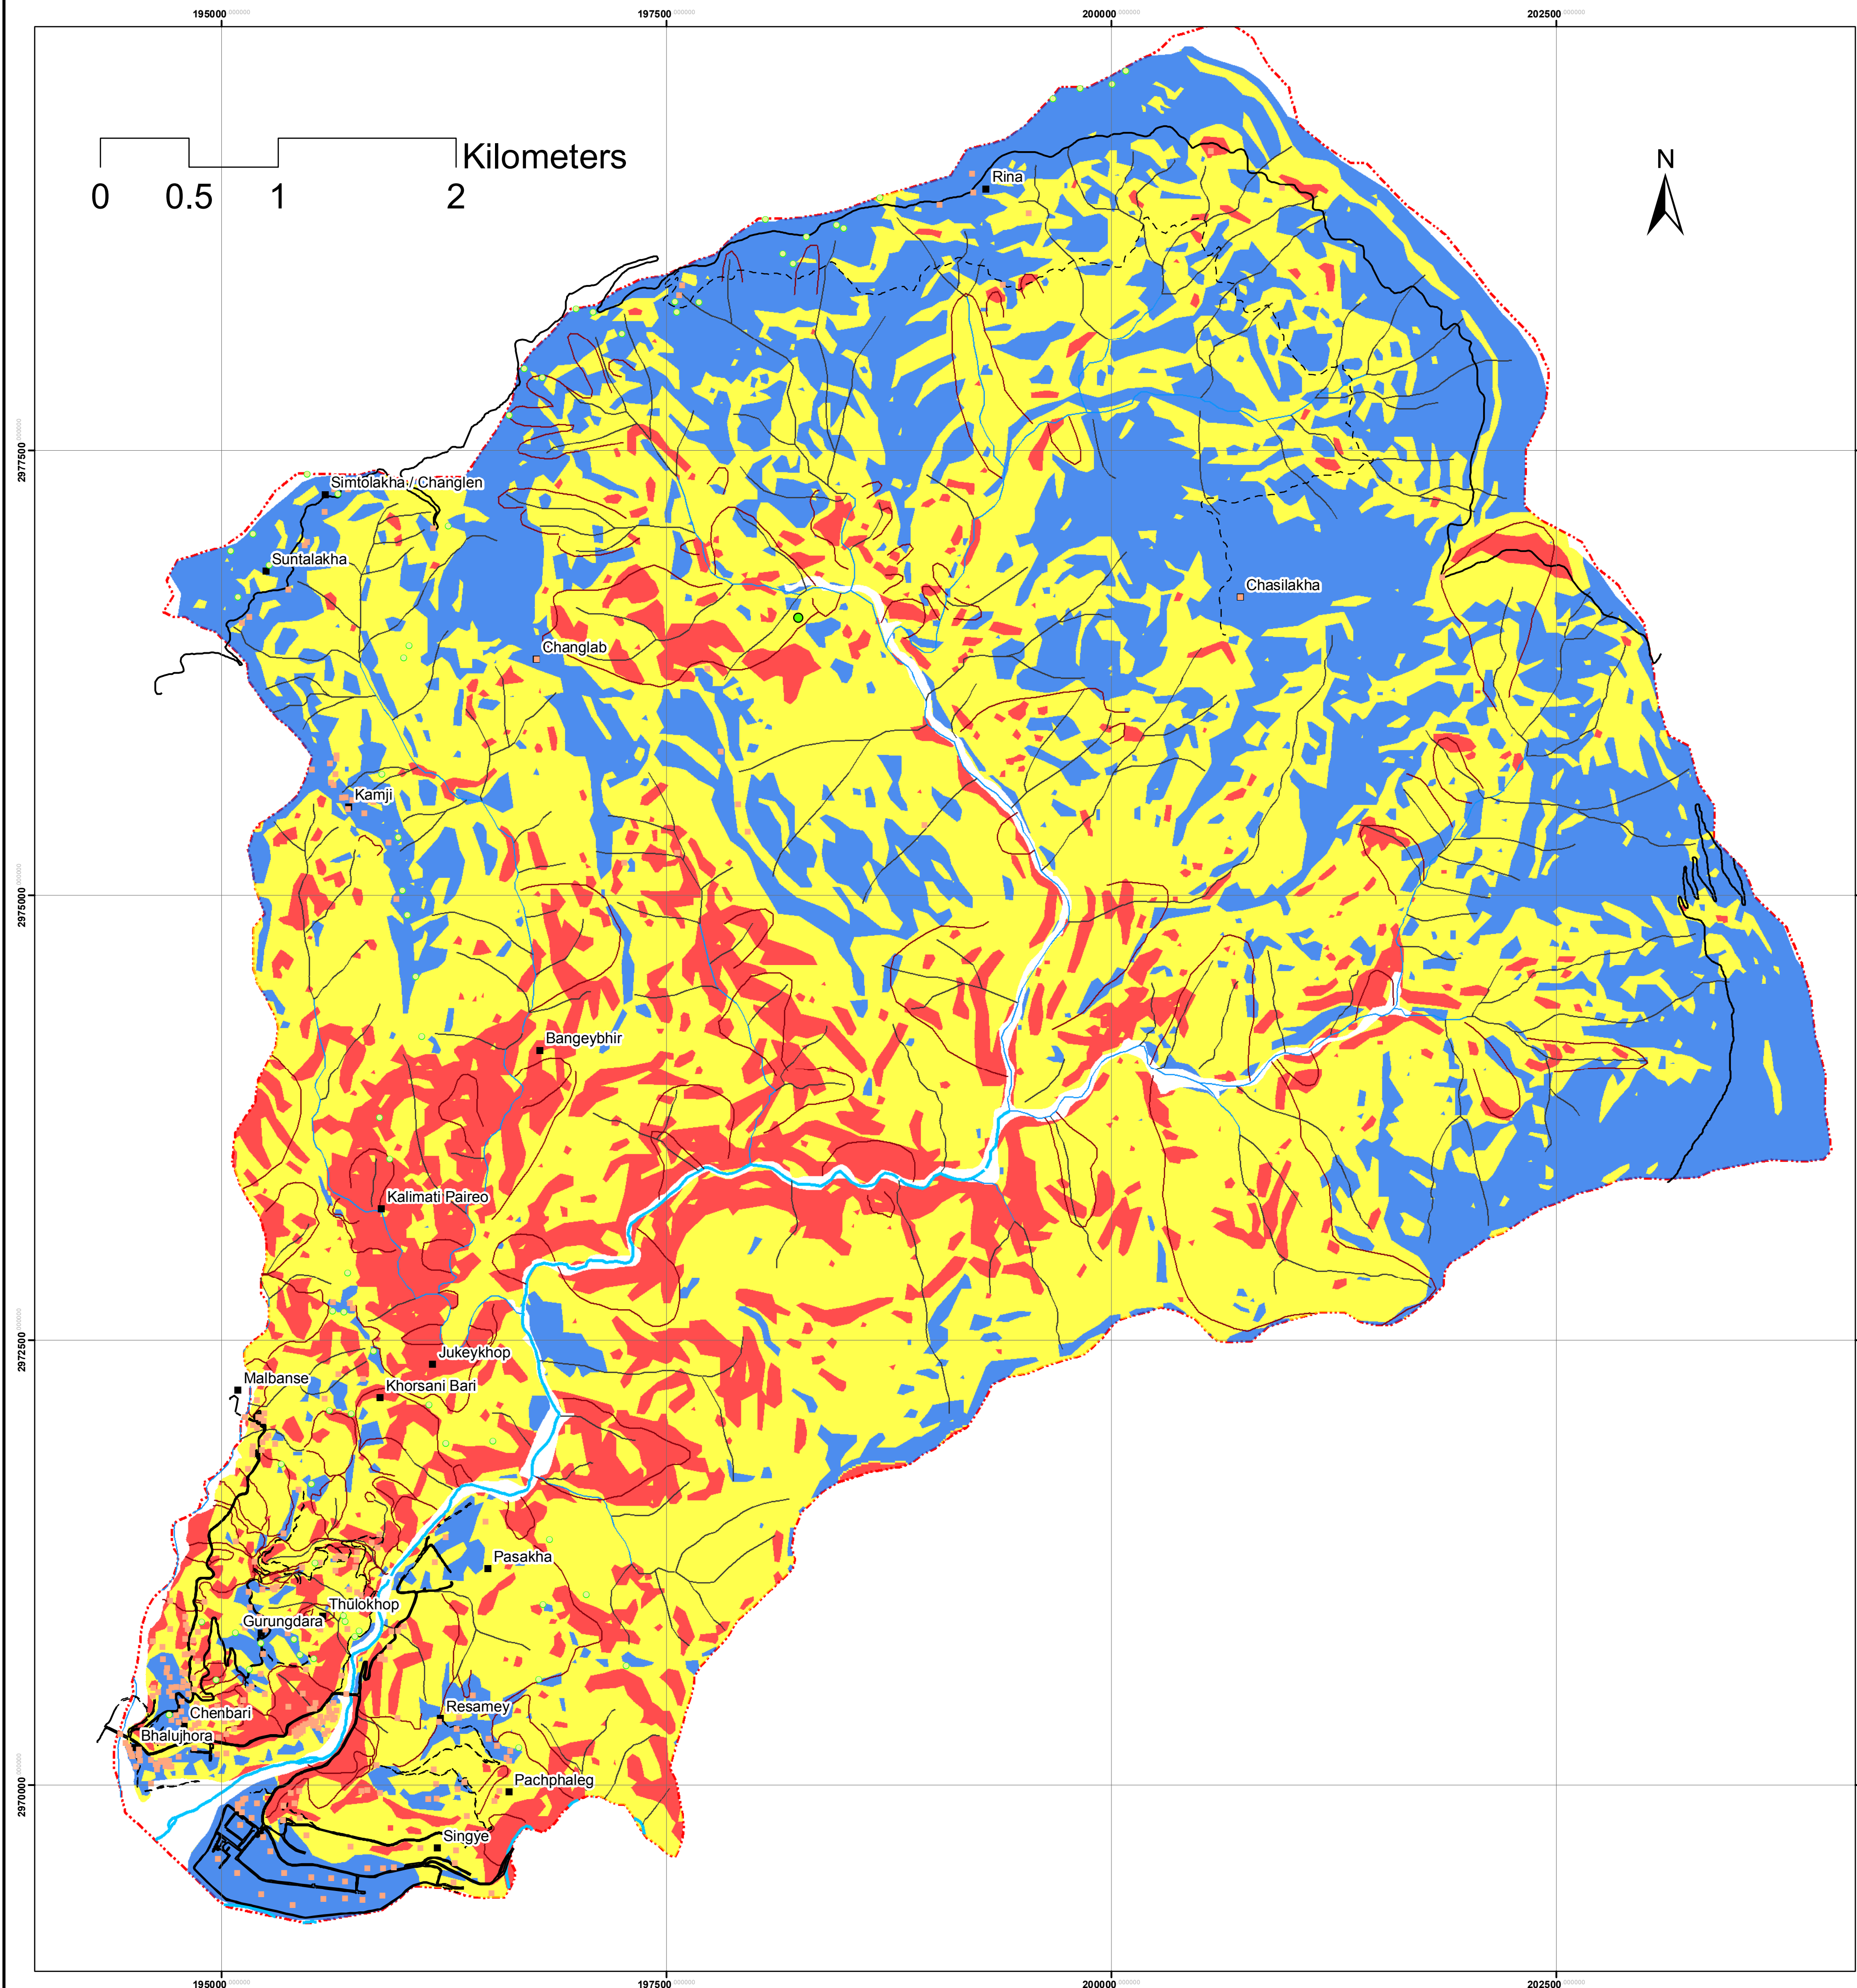
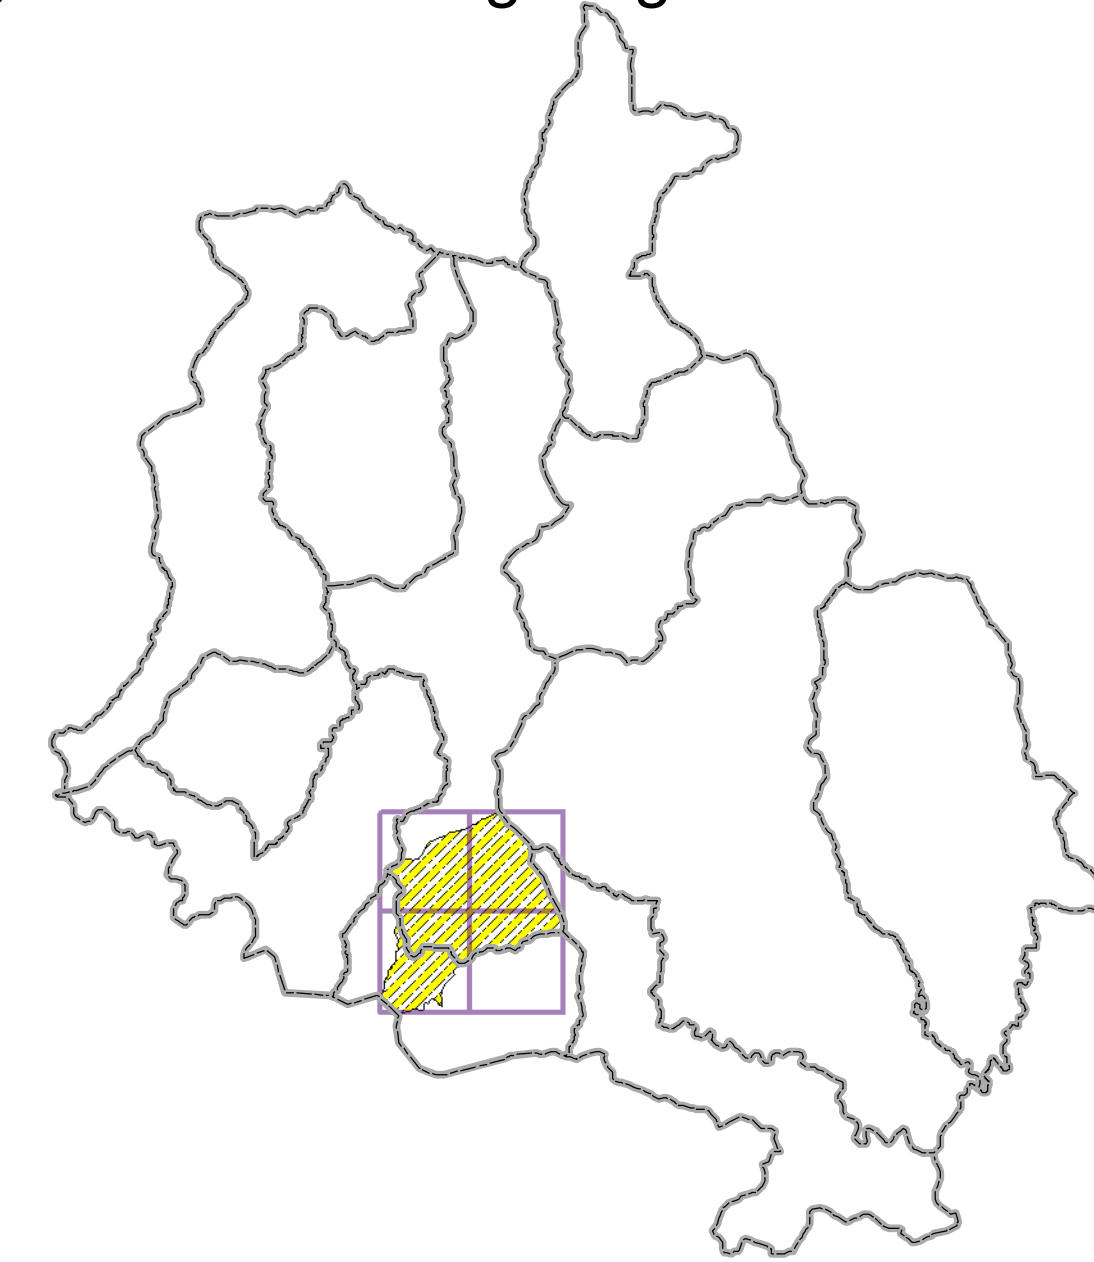
# Plate:3 Integrated Hazard Zonation Map of Barsa Catchment, Chhukha Dzongkhag

The landslide hazard map or results indicate that the watershed is predominantly (~55 percent) occupied by moderately high landslide hazard, corresponding to 31.17 Km<sup>2</sup> of the watershed area; followed by ~30 percent indication of low hazard, which corresponds to 17.39 Km<sup>2</sup>; and ~15 percent high hazard zone corresponding to 8.42 Km<sup>2</sup> of the watershed area. The south-west part of this watershed as compared to other parts is indicated as the highest concentration of high and moderately-high landslide hazard. This coincides with the highest concentration of the socio-economic elements such as the Pasakha Industrial estate and industrial colonies etc.

The Integrated Landslide Hazard Zonation Map of Barsa watershed is provided as Plate-3. The area coverage details by different hazard levels are shown in Table 7. The hazard level results indicate that the watershed is predominantly (~55 percent) exposed to moderately-high landslides hazard corresponding to 31.17 Km<sup>2</sup> of the watershed area; followed by ~30 percent indication of low hazard, which corresponds to 17.39 Km<sup>2</sup>; and ~15 percent high hazard zone corresponding to 8.42 Km<sup>2</sup> of the watershed area. The south-west part of this watershed as compared to other parts is shown as the highest concentration of high and moderately-high landslide hazard. This coincides with the highest concentration of the socio-economic elements such as the Pasakha Industrial estate and industrial colonies etc. The socio-economic elements falling under different hazard levels in this watershed

Proper geotechnical or engineering geological studies are recommended before constructing any infrastructures in the medium and high hazard areas. For now, the low or no hazard areas seem safe for construction, but these areas are recommended to be monitored at least on yearly basis and verified by professionals before any developmental planning to ascertain that the geological, hydrological, topographical and other ground conditions have not varied significantly.

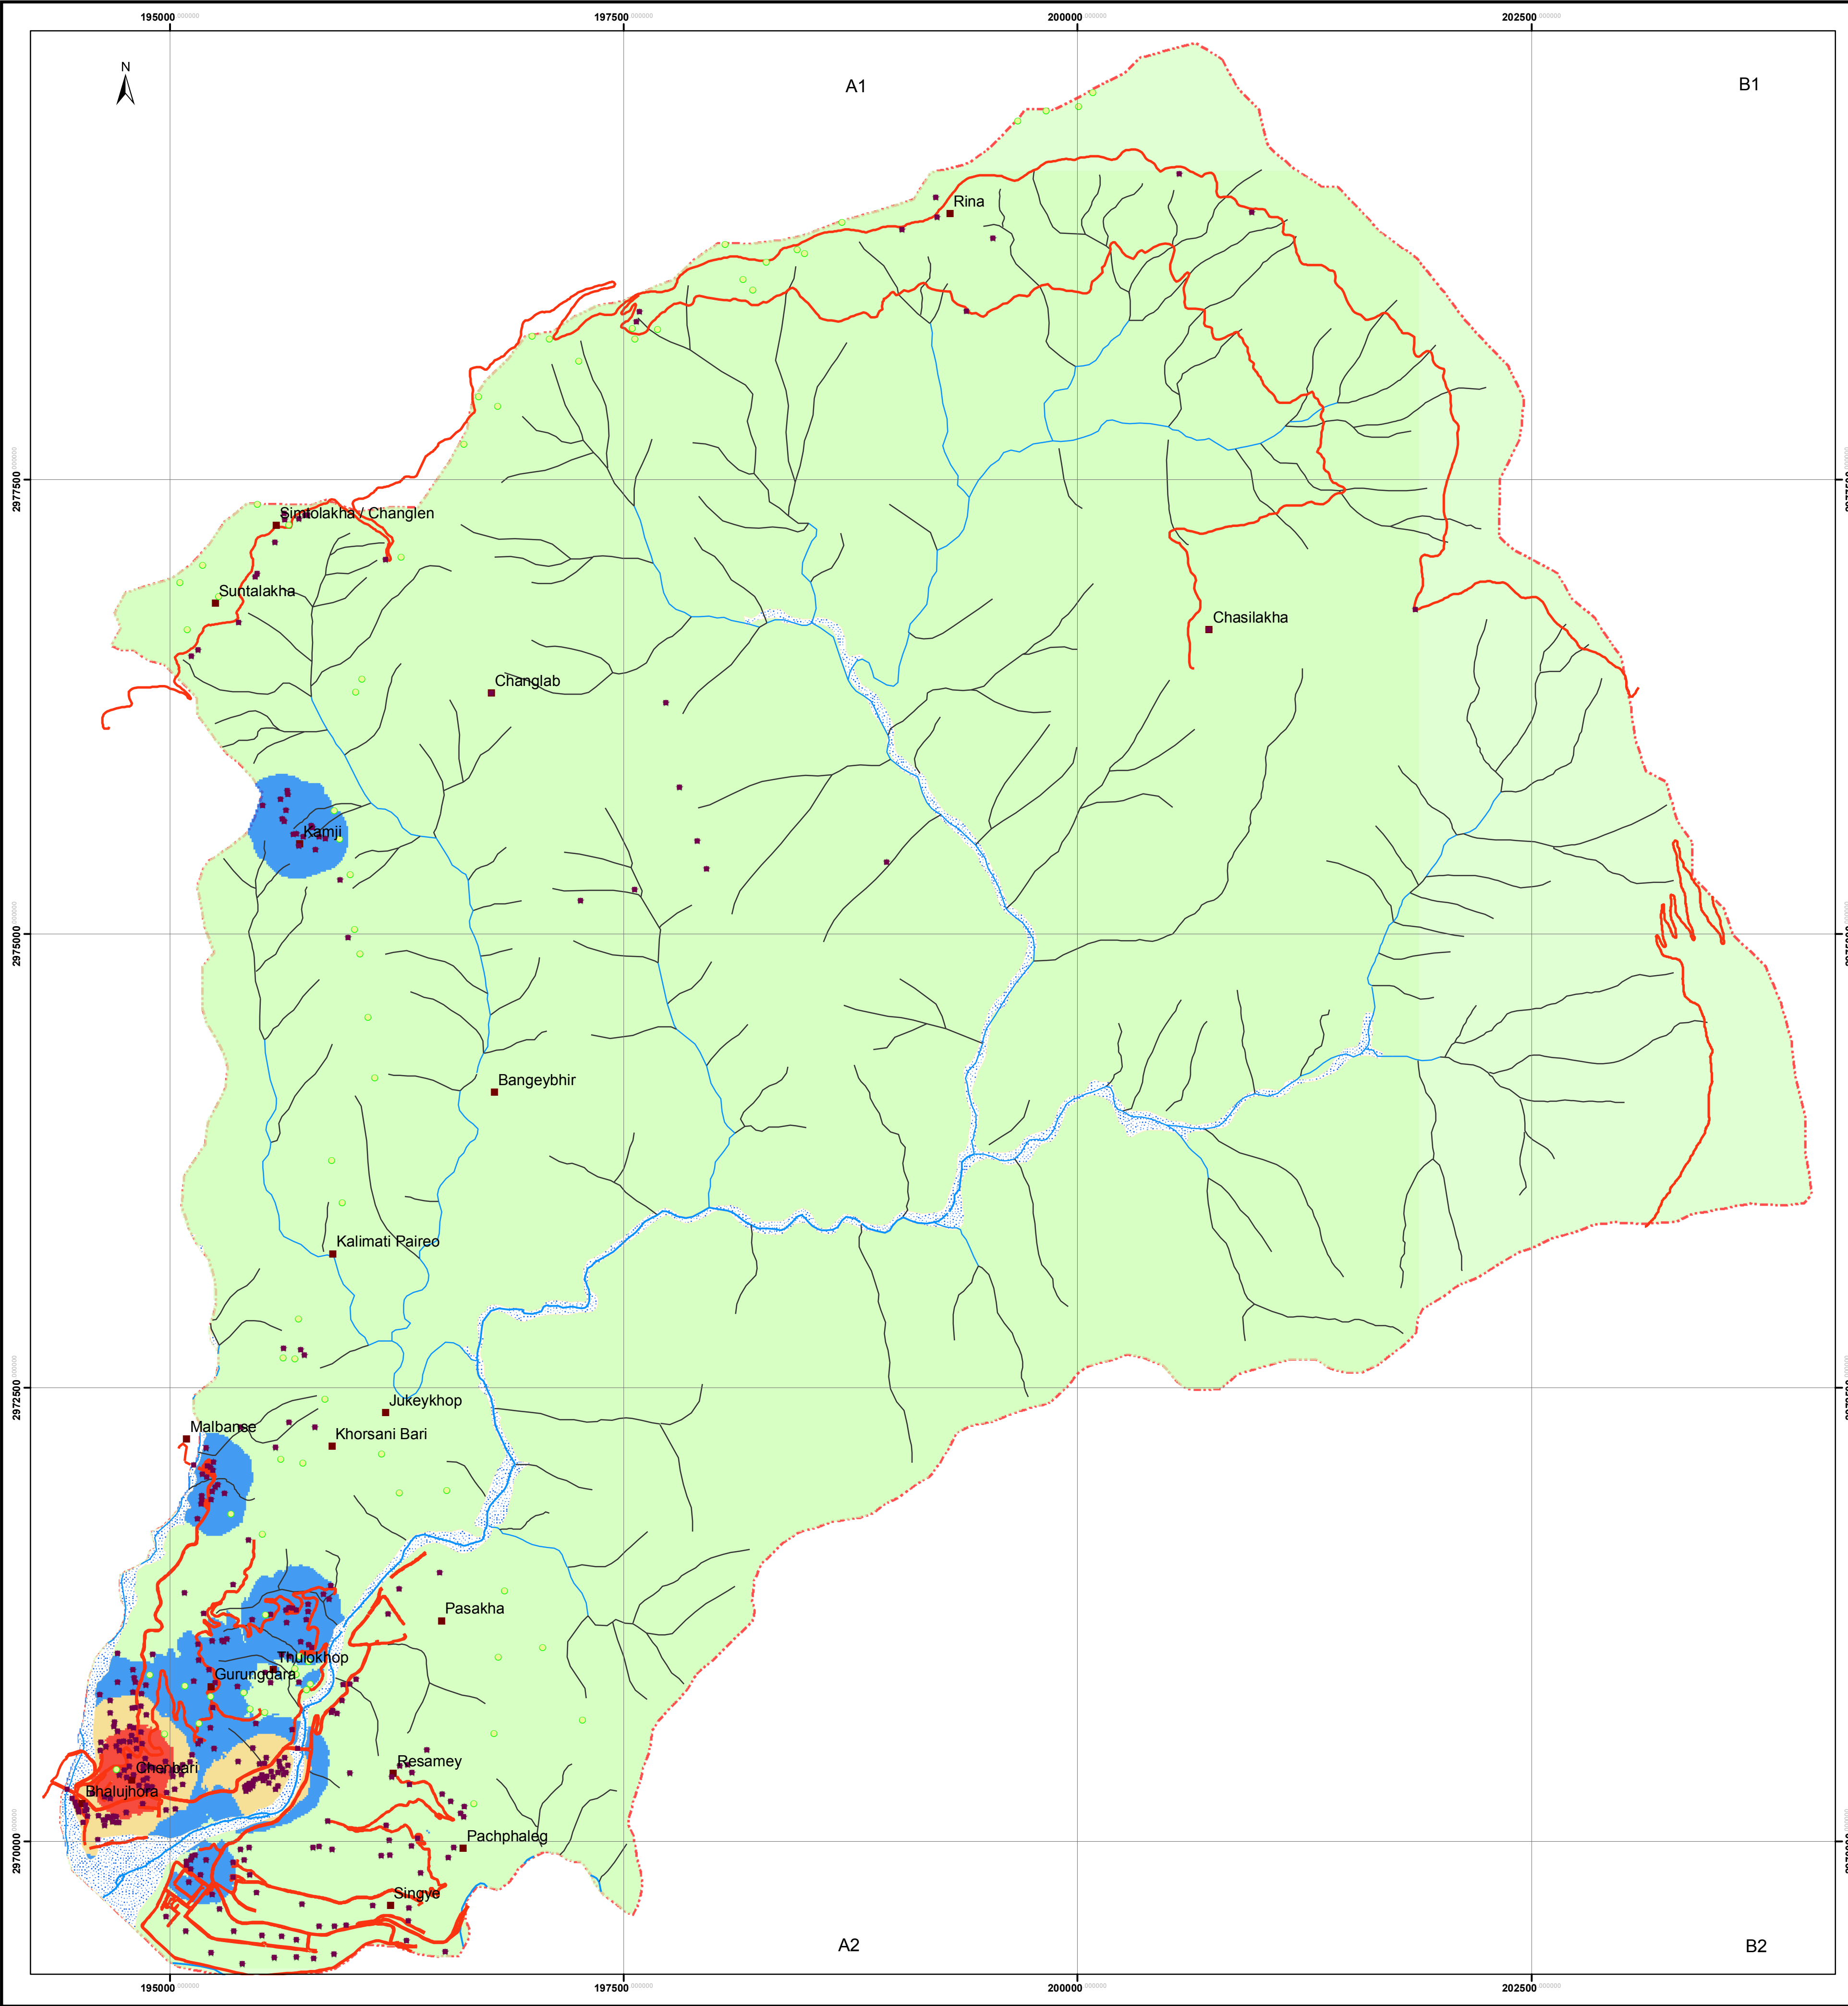
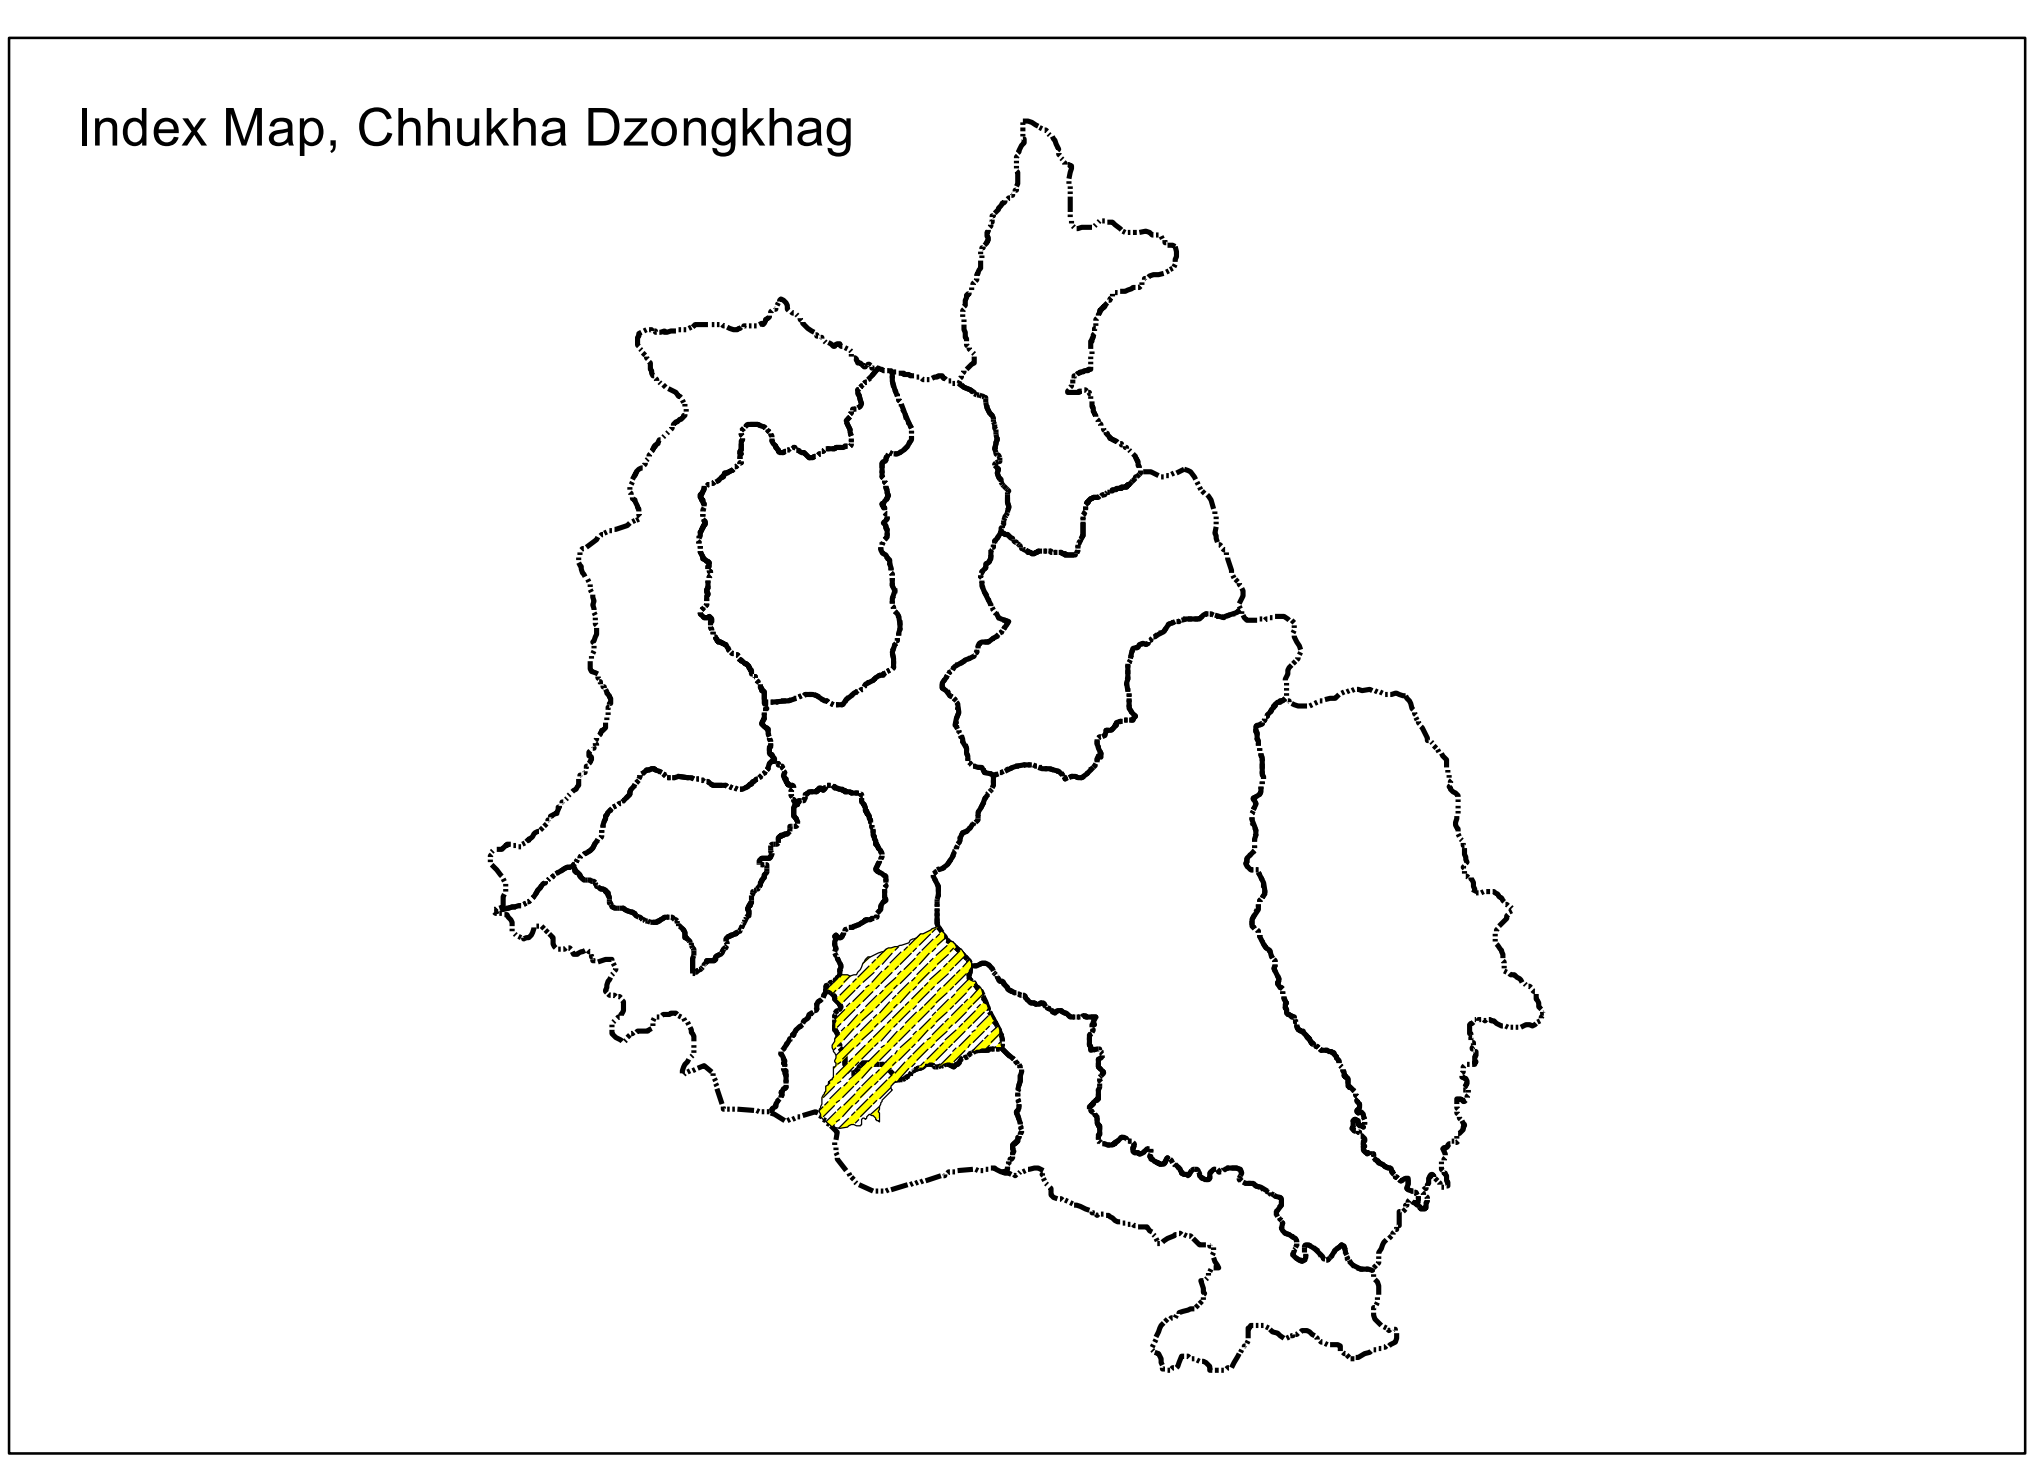
# Plate:5 Risk Assessment Map of Barsa Catchment, Chukha Dzongkhag

The landslide risk map results indicate that ~96 percent of the watershed area is exposed to low or no risk of landslide hazard, corresponding to 56.27 Km<sup>2</sup>; ~2.4 percent of the area to moderately-low risk corresponding to 1.41 Km<sup>2</sup>; < 1 percent to moderately high corresponding to 0.48 Km<sup>2</sup>; and 0.3 percent to high risk, which correspond to 0.17 Km<sup>2</sup> of the watershed area. The south-west part of this watershed as compared to other part is more exposed to landslide risks. This coincides with the highest concentration of the socio-economic elements such as the Pasakha Industrial estate and industrial colonies etc. A cultivation land of 29.15 acres, 38 houses and 174 people (as counted during the socio-economic survey); a cultivation land of 44.06 acres, 57 houses, 1062 people, 1 BPC high tension pylon; 144.55 acres of cultivation land, 70 houses, 1546 people and 8 BPC high tension pylon are indicated to be located within high-risk area, moderately high-risk, and moderately low-risk area, respectively.

This study recommends for further detailed studies such as engineering geological or geotechnical and hydrological studies (along the Barsa river) to be carried out on a priority basis to assess the risk in areas designated as high-risk areas to come up with scientific-based sustainable remedial or mitigation measures to reduce risks.
