Integrated Geo-Hazard Risk Assessment of Critical Landslide at Box-Cutting, Gelephu-Zhemgang Highway, under Sarpang Dzongkhag

Department of Geology and Mines

Field Season: 2015-2016

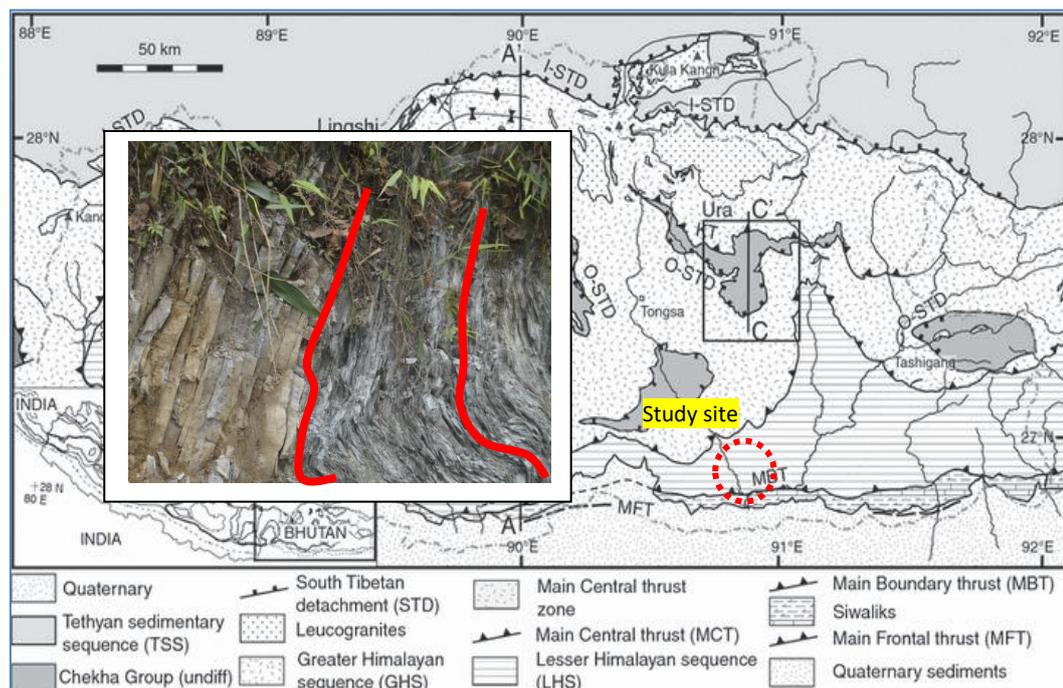
Figure 4. A general overview of the tectonic situation of Box-cutting slide (Modified after Kellett et al., 2009)

has played the main role in being part of the factors for rock sliding events. The evidence for folding in the study area is observed and shown in the Figure 4. The rocks in the study area are highly sheared and fractured, which has led to a weakening of rock mass. These tectonic effects in rocks in long run has triggered huge rockslide in the area.

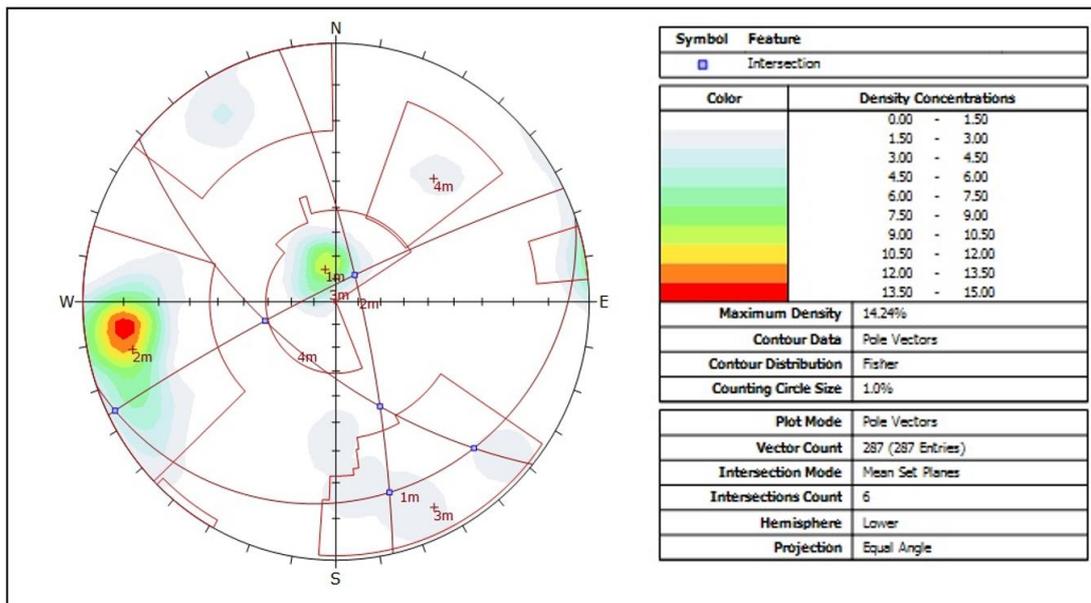
Figure 10. Stereo representation of information from the site.

Plotting of hundreds of attitudes of joints from quartzite and phyllite on the stereo also show four sets of the joints (Figure 10). The maximum density shown is 14%.

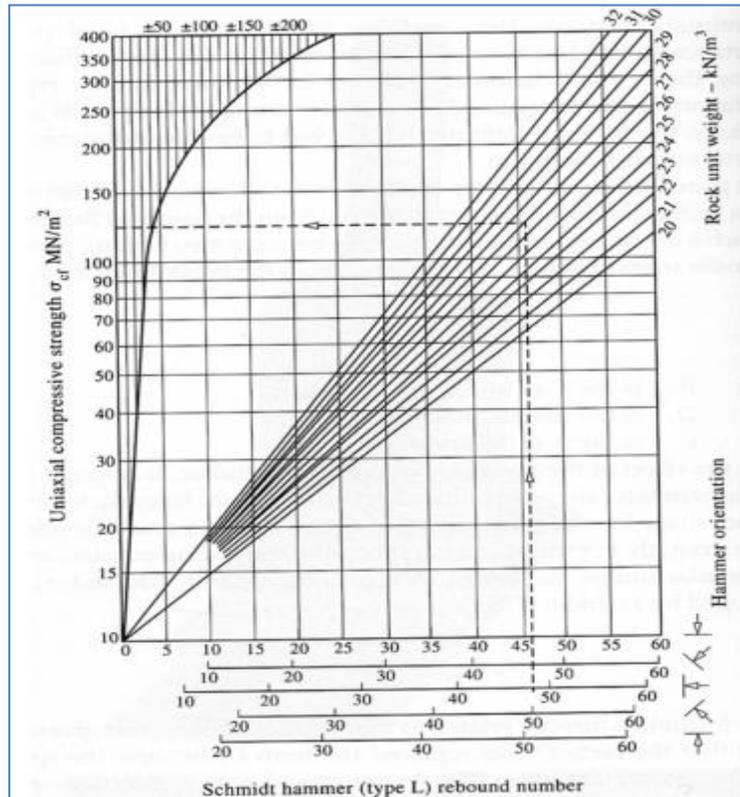
Figure 11. Calculation of UCS values from Schmidt hammer rebound and empirical curve.

Further, the numbers of the readings of the Schmidt hammer on the phyllite were taken and analysed for the compressive strength of the rock. The mean of the strength tested at the site with Schmitt hammer is provided in Table 3. The Joint Compressive Strength can be estimated from Schmidt hammer readings by using empirically determined curves constructed for various hammer types and orientations (Figure 11). For phyllite, the Uniaxial Compressive Strength is estimated to be in the range of 15 MPa since it requires a blow of the geological hammer to a fracture the rock. Although quartzite is highly weathered at the surface and fractured, it requires more than one blow of the geological hammer to create fracture in it, so the UCS is estimated in the range of 30-100 MPa based on Uniaxial Compressive Strength classification of ISRM 1978. This indicate that the areas with quartzite as underlying bedrocks are relatively more stable as compared to areas lying on phyllite.

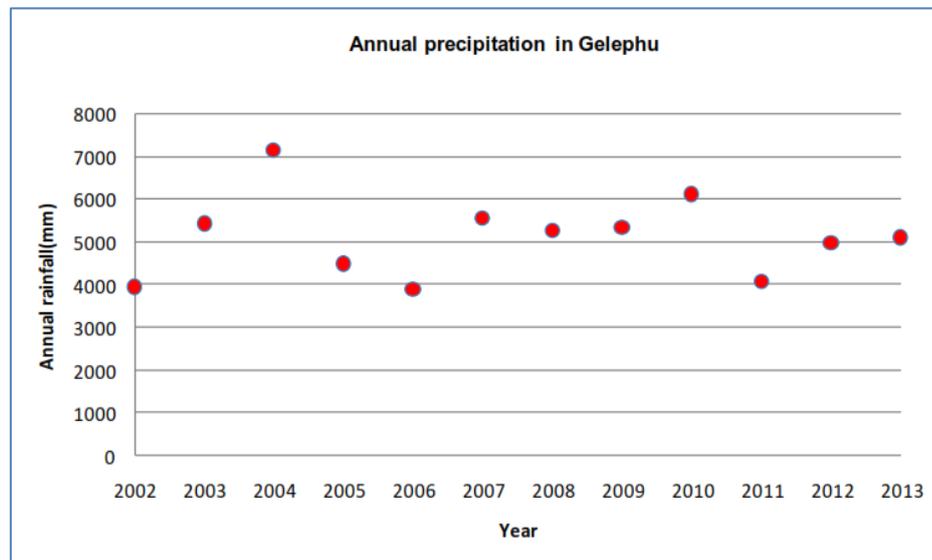
Figure 12. Annual precipitation of Gelephu area for past 12 years (source National Center for Hydrology and Meteorology).

The rockslides are driven by natural or human activity induced triggering factors. Often, rockslides are caused by the structure of the slope. Rainfall data from 2002 to 2013 show that the area receives heavy precipitation during the monsoon season (Figure 12). Therefore, besides steep slope ($>45^\circ$) and weak fractured nature of the rock mass, rainfall is most likely one of the main driving forces of the rockslide in Box-Cutting area.

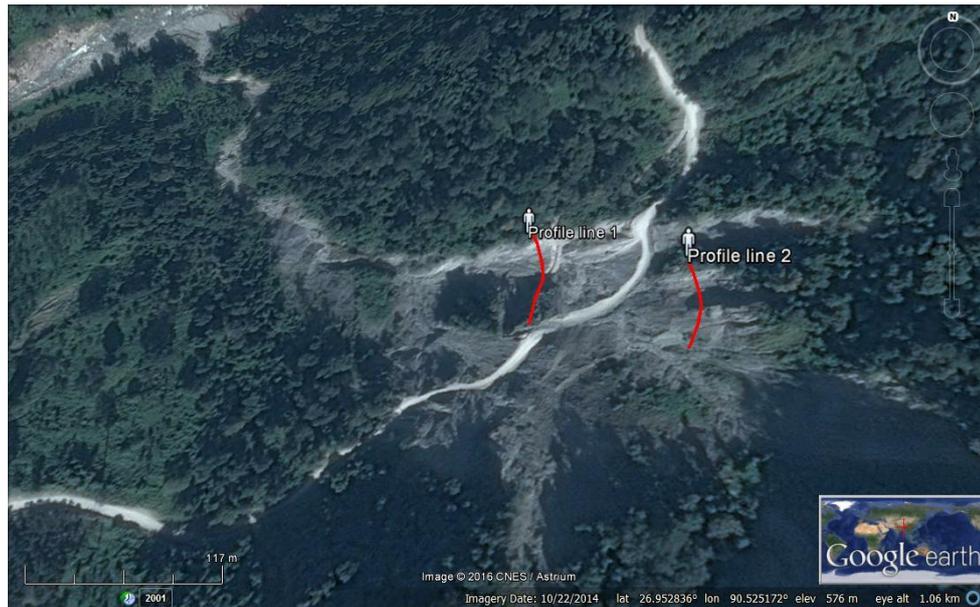
Figure 16. Electrical Resistivity Tomography profile layout in the study area shown on Google Earth by the red line.

Two electrical resistivity profile lines were conducted (Figure 16). ZZ array developed by the FlashRes Universal equipment manufacturer and other standard configuration such as Wenner, dipole-dipole and Schlumberger were used to collect data. Electrode spacing of 3 m was selected for all profile line 1. In the case of profile 1, 32 electrodes were used, whereas for other profile only 32 electrodes were used with a spacing of 5m.

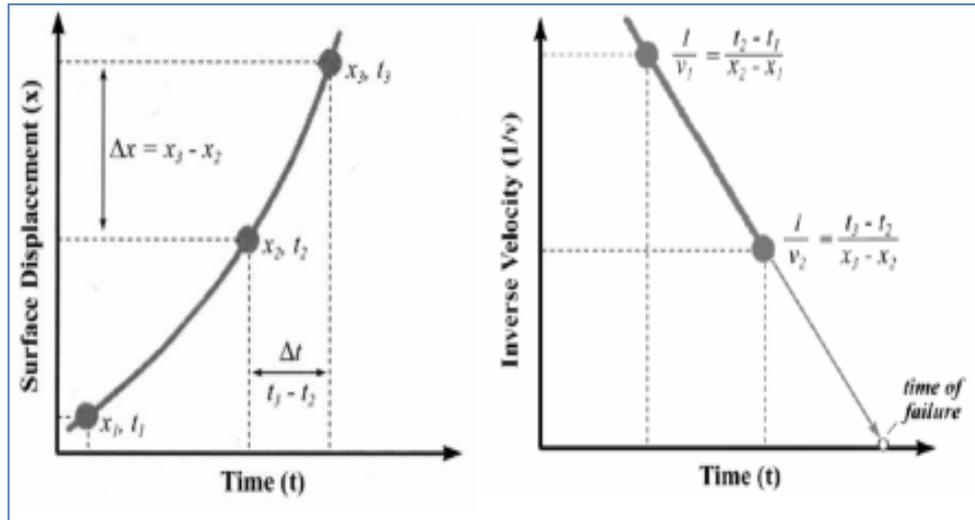
Figure 21. Inverse velocity method to predict the time of failure (Fukuzono,1985).

This method is considered as effective to estimate the failure time, but it is fully dependent upon velocity against time. The failure time can be estimated as shown in Figure 21. The inverse velocity versus time has been plotted in linearly and the line when intercept the time 't' axis, this time could be critical for failure. Because failure time can be influenced by other factors like degree of weathering and the amount of rainfall received by the area, therefore this method has a limitation in estimation.

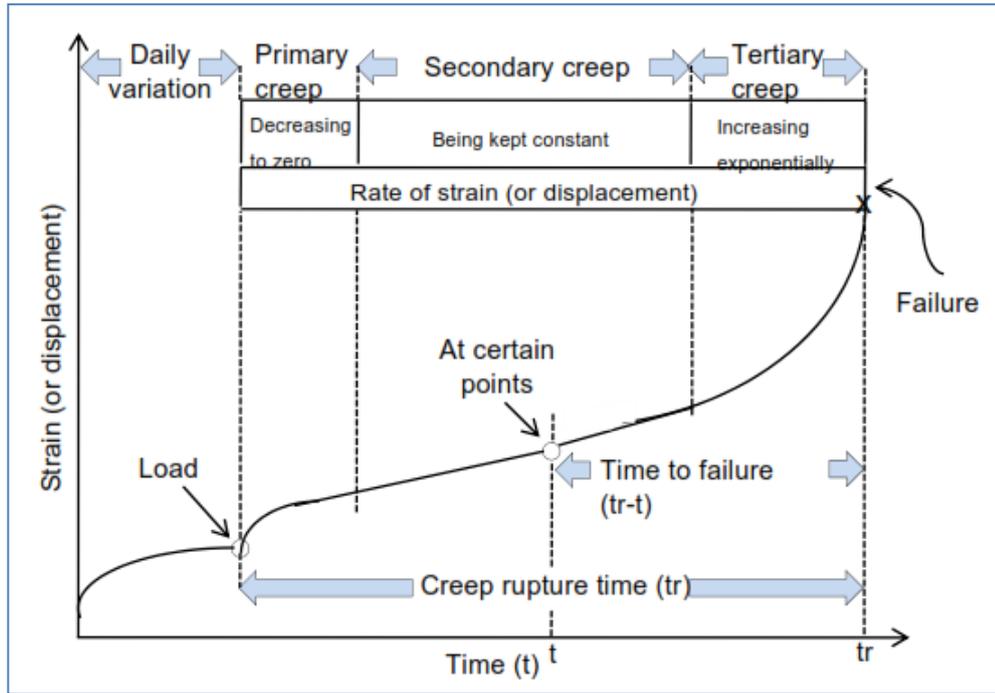
Figure 22. Relationship of strain and time series of creep deformation (Saito 1965).

The other popular method of estimating the failure time is using creep method (Figure 22) of Saito (1965). This method comprises of the three general phases as indicated in the Figure 22. It is basically based on time-dependent deformation. In the Box-Cutting, the displacement of the unstable mass is directly proportional to the opening of the tension cracks and progressive failure. Therefore, creep method seems better method to estimate the failure time in Box-Cutting. Since failure probability is high during monsoon, it will require the collection of displacement and rainfall data to use creep method to estimate the failure time and a threshold of rainfall for sliding in the area can be estimated.
