# Watershed Management Plan for the Baychhu Watershed, Punatsangchhu Basin

Ministry of Agriculture and Forests  
Royal Government of Bhutan

**Watershed Management Division**

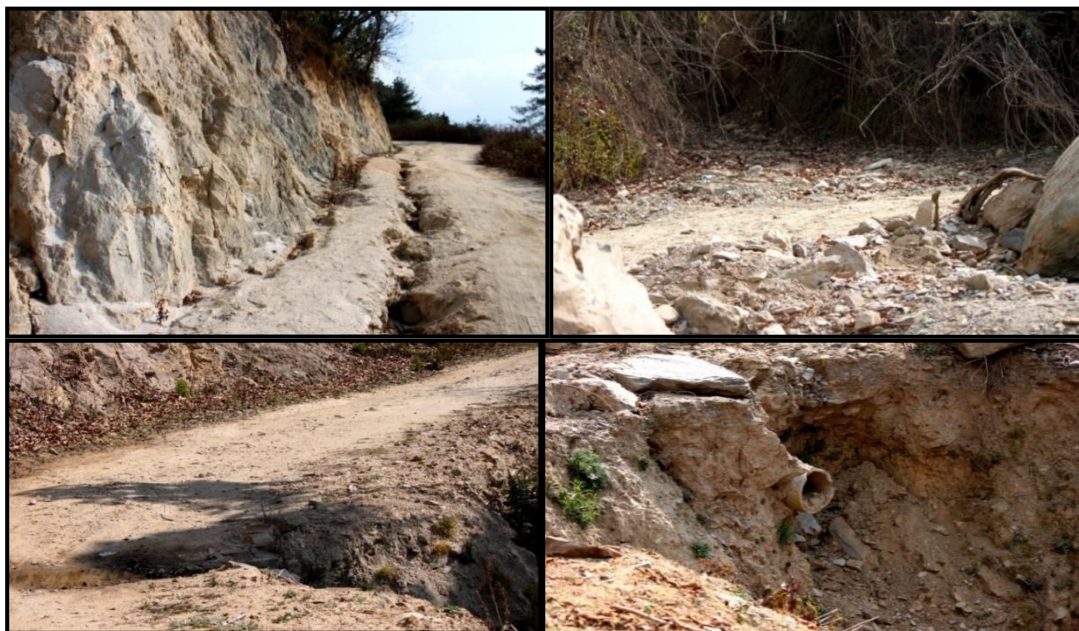
Most of the farm roads in the watershed lack proper drainage systems, leading to increased erosion and landslides. Many of the cross-drains that are installed are non-functional or apparently due to the pipes being undersized (Hume) and the absence of catch pits. During the rainy season, the Hume pipes become blocked with sediment and debris causing roads to overflow leading to landslides and gully formation. During heavy rainfall, the farm roads themselves become water channels.

Photo 1: (A) Absence of drainage on farm roads & water channel formation. (B) Lack of catch pits on depressions & streams along farm roads. (C) Blockage of hum pipes being too small in size & also due to lack of catch pits and debris entering & blocking the hume pipe diverting water onto farm roads. (D) Gully formation on farm roads

The impact of farm roads is prominent in the entire watershed area and they are in fact the major cause of landslides in the area. As explained earlier, due to poor road design and incomplete or improper construction practices, landslides and erosion are common along farm roads.

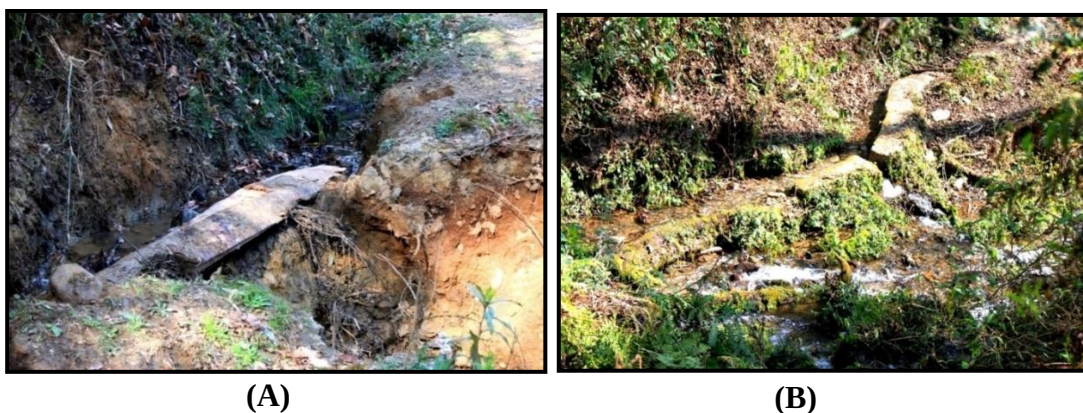
Irrigation channels are one of the most important types of structure in the watershed and have helped to maximize the amount of land that can be irrigated. Generally, irrigation channels are lengthy and built on natural slopes and so they are prone to leaking. On the one hand, this reduces the amount of water supplies at the end point and on the other hand it exacerbates the risk of land slips due to seepage. Examples of this nature can be seen in Chebakha in the Nyisho Geog where paddy fields have been found to be sinking at several locations. In other areas, overflows from irrigation channels are discharged on to farm roads which affect their condition.

Photo 2: (A) Overflow & leakage of irrigation channel. (B) Damaged irrigation channel

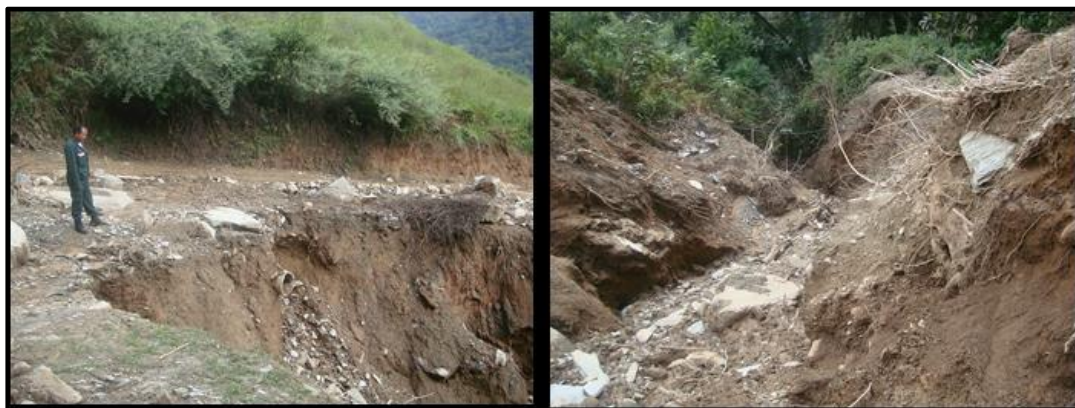
At the time of the field inspection, three landslides were observed along the main 20 km farm road (see Photo 3: Landslides within watershed

Photo 3). This road has no proper drainage system. These landslides are sources of sediment loads into the Baychhu drinking water sources. Other activities like small scale granite quarries and the felling of trees within the drinking water supply catchment are impacting on water quality.

(A) Photo 3: Landslides within watershed (B)

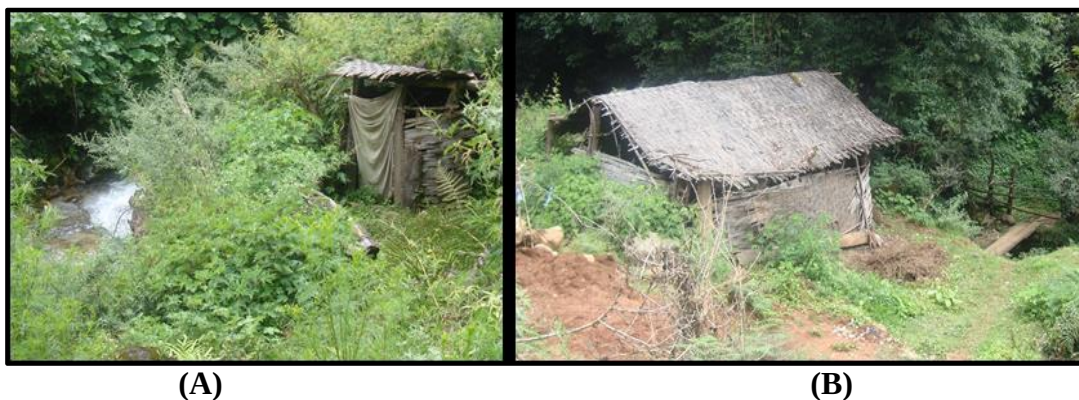
Photo 4: (A) Pit toilet & (B) Cowshed located on bank of Baychhu

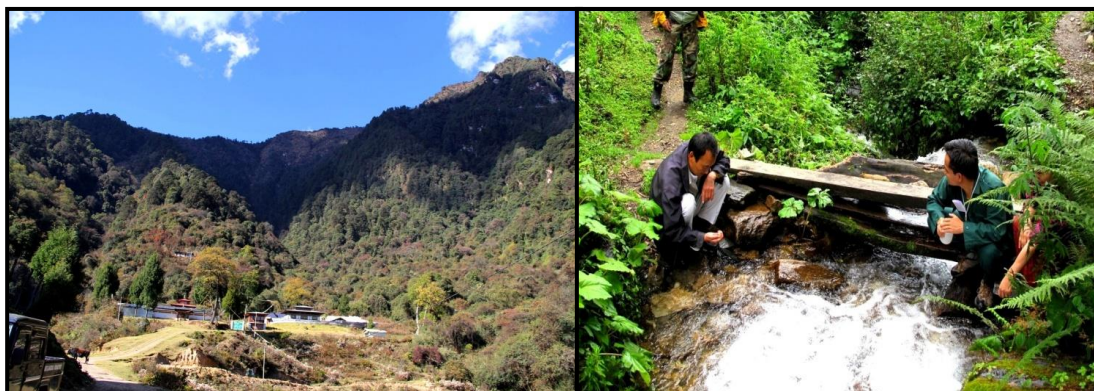
Photo 5: (A) Undisturbed upper catchment above & adjacent to Baelangdra Ney where Baychhu originate. (B) Baychhu source during monsoon

High sediment loads from agriculture fields, farm roads and degraded land areas are also discharged into the Baychhu thus making the water undrinkable especially during the monsoon period. Disposal of animal carcasses in the stream is also a common reported practice which pollutes the water and poses health risks to downstream consumers. Based on the field inspection and the analysis of water quality test results in Table 7 & 8 and Figures 12, 13 & 14, the following comments are provided regarding water quality in the Baychhu watershed. The very upper reaches of the watershed (upstream of the monastery) have almost no development and can be considered pristine. The water has a neutral pH, reasonable levels of dissolved oxygen and low levels of turbidity and conductivity. Nutrient concentrations are typical of forested catchments.

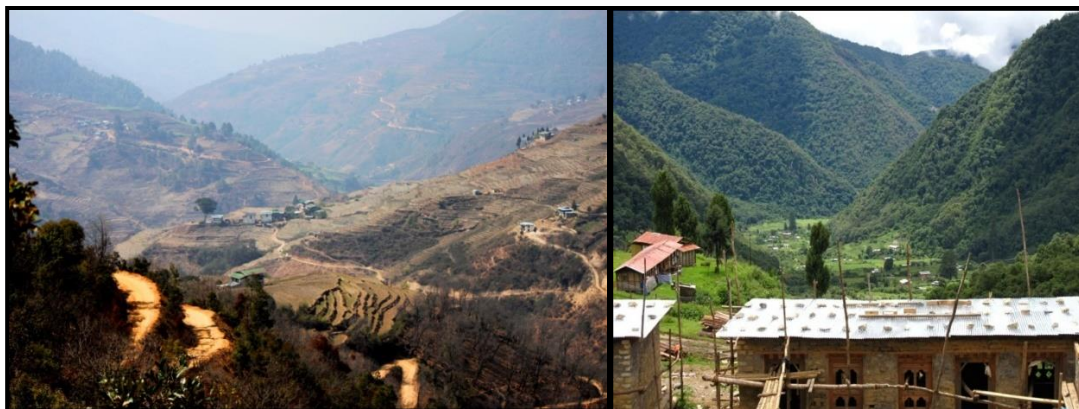
Photo 6: (A) Settlements at upper to mid watershed. (B) Landuse practices in lower watershed

The middle and lower reaches of the watershed include scattered human settlements and farms. Water from tributaries in these areas can therefore be expected to have a higher turbidity due to the higher level of disturbance. Some of the samples collected in this area showed very high phosphate concentrations, possibly due to fertilizer use, however nitrate levels are low and well below guideline levels.

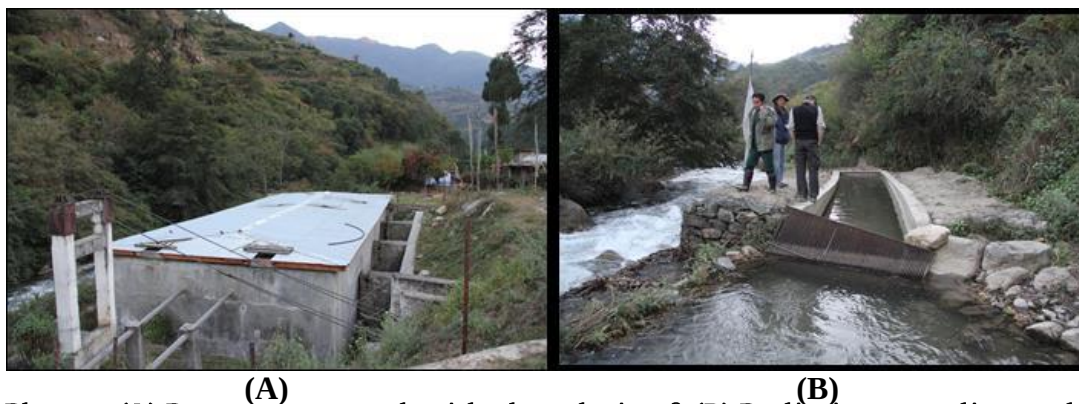
Water from the Baychhu watershed is used as drinking water source for the Bajo Town, army camp, Dratshang, hospital colony, local schools and other Bajo communities. It is also used for irrigation purpose. Baychhu is also one of the major tributaries of the Punatsangchhu which contributes to hydro-power generation. Leaching of agricultural chemical residues (eg: fertilizers/pesticides) and sediments into waterways are therefore of concern. However, there is a need to accurately measure the concentration of pollutants in the water supply to assess the associated risks and plan accordingly to address any issues. The drinking water offtake is shown in the photo below.

Photo 8: (A) Pretreatment tank with alum dosing & (B) Preliminary settling tank collecting debris at drinking water offtake at Rikizampa

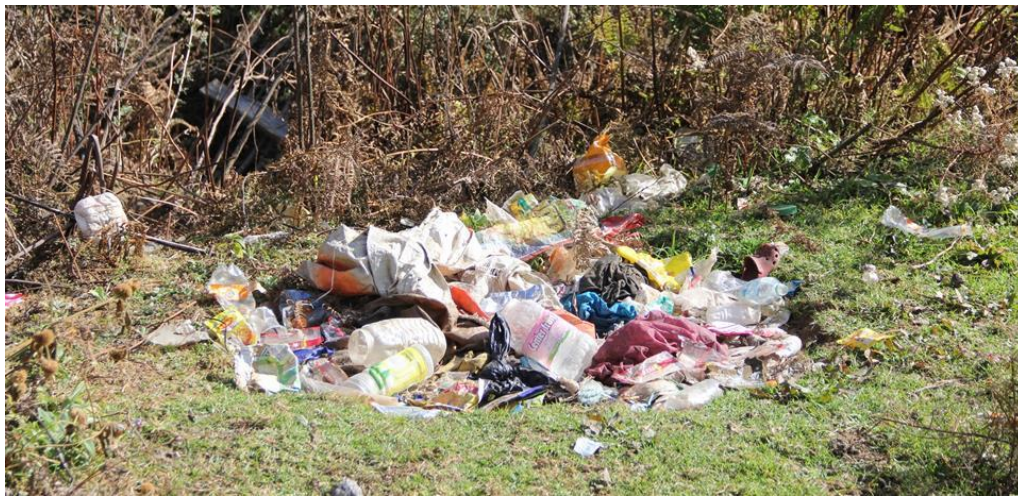
Photo 9: Open waste disposal in the watershed

The lack of toilets has led to open defecation and pollution of water sources in the watershed. Further, waste water from household uses also drains to the Baychhu. Waste management could be improved if

awareness meetings are conducted in parallel with the establishment of necessary facilities such as concrete waste pits and dust bins in strategic locations. Establishing links with the Wangdue Municipality for waste collection at these locations is also necessary. It would also be helpful if cleaning campaigns are conducted regularly along the Baychhu itself as well as other areas where current waste management is poor.

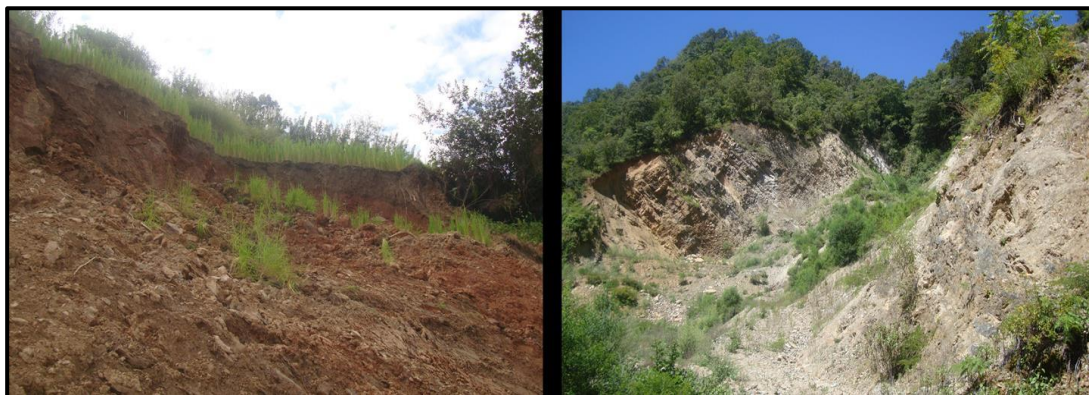
Photo 10: Landslides in watershed

future. Measures include construction of check dams and retaining walls combined with growing of shrubs and grasses for stabilizing slopes and ensuring proper drainage system along farm roads. On vulnerable and degraded sites, sustainable land development and management techniques including contour hedgerows, terracing (particularly in Phanuyuel where there is water scarcity) and SALT (Soil And Agriculture Training) can be adopted to conserve soil and moisture and prevent starting of erosion which will also help improve land productivity.

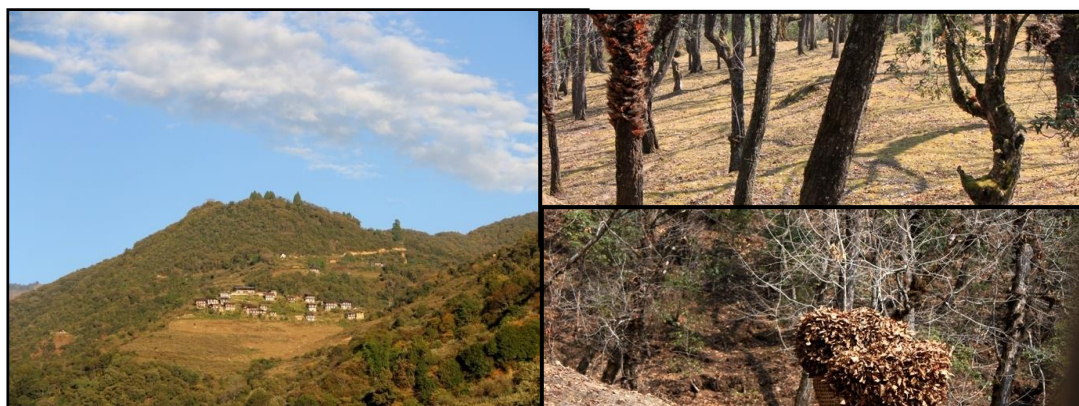
Photo 11: (A) A typical farmland with secondary forests on top and surrounding areas. (B) Sokshing forests

The traditional practice of Sokshing (Life tree) is a woodlot in the vicinity of settlements which is an important component of farming systems in all three Geogs. Sokshing practice was found generally well managed and is in good condition as shown in photo below. The sokshing is a source of organic manure for the farmlands. The surrounding secondary forests are also a source of fuel wood, timber and other forest produce used for domestic consumption

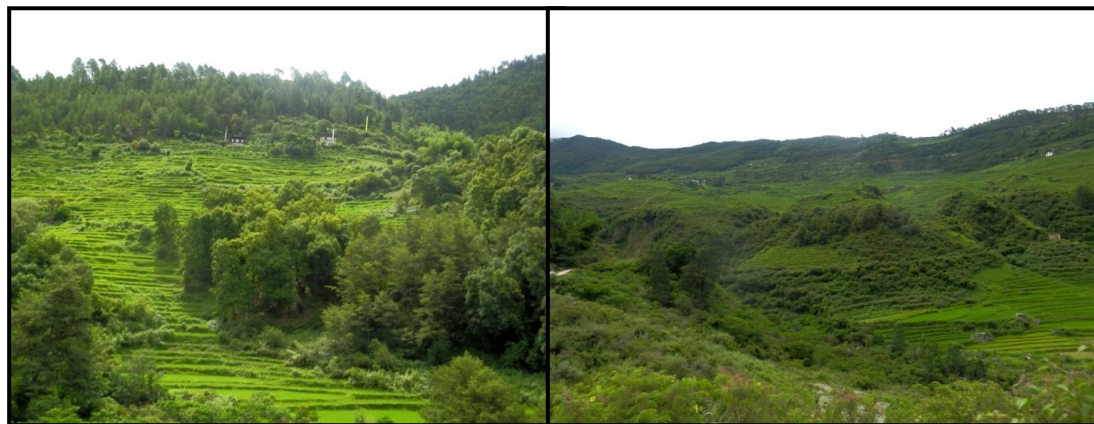
Photo 12: (A) Farmland with buffer vegetation & (B) Farmland with hedges in the interspaces

In the mid valleys, most of the agricultural lands and paddy fields are interfaced with vegetation cover mostly in the form of hedges (see Photo 12). However, with development, network of farm roads were constructed that have lead to fragmentation of agriculture and forest ecosystems. Such activities may lead to severe disturbances in the near future.
